Access Compliance Report

Public Rights-of-Way

(Curb Ramps)

Intersection ID: 48435	Main Street: BEDLINGTON_RD	Cross Street: SEAMILL_RD	Location: NE
ADA ID: 2337EA49DDBE	Ramp Type: PerpDiag	Initial Pass/Fail: Fail	Overall Compliance: No
		Severity Score: 8.75

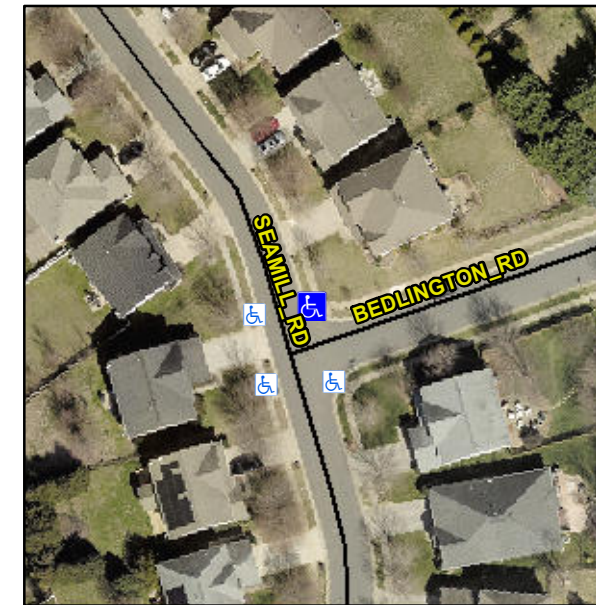
Compliance	Description	Data	Compliance	Description	Data
N/A	Ramp Length (in)	47.0	Yes	Ramp Slope (%)	6.2
No	Ramp Width (in)	47.0	Yes	Ramp XSlope (%)	0.7
N/A	Flare Type LT	N/A	N/A	Flare Type RT	N/A
N/A	Flare Slope LT (%)	N/A	N/A	Flare Slope RT (%)	N/A
N/A	Flare Traversable LT?	N/A	N/A	Flare Traversable RT?	N/A
N/A	Landing Length (in)	N/A	N/A	DWS Provided?	N/A
N/A	Landing Width (in)	N/A	N/A	DWS Contrast?	N/A
N/A	Landing Slope (%)	N/A	N/A	DWS Length (in)	N/A
N/A	Landing X Slope (%)	N/A	N/A	DWS Full Width?	N/A
N/A	Landing Curb? (Y/N)	N/A	N/A	DWS Offset (in)	N/A
N/A	Shared Landing?	N/A			
N/A	Gutter Ponding?	N/A	N/A	Gutter Slope (%)	N/A
N/A	Gutter Lip Ht (in)	N/A	N/A	Gutter X Slope (%)	N/A
N/A	Painted X Walk1?	No	N/A	Painted X Walk2?	No
	X Walk 1 Direction	To W		X Walk 2 Direction	To S
N/A	X Walk 1 Width (in)	N/A	N/A	X Walk 2 Width (in)	N/A
	X Walk 1 Slope (%)	3.3		X Walk 2 Slope (%)	0.1
	X Walk 1 X Slope (%)	0.9		X Walk 2 X Slope (%)	0.5

N/A	Ramp inside XWalk1?	N/A	N/A	Ramp inside XWalk2?	N/A
	Road Slope (%)	0.5	N/A	Clear Space?	N/A
	Road X Slope (%)	0.5	N/A	Clear Space to XWalk (in)	N/A
N/A	Any Obstructions?	N/A	N/A	Storm Grate/Utility Hazard?	N/A
	Obstruction Type			Storm Grate/Utility Type	
		N/A			N/A
		Yes		Surface Condition? (G/P)	Good

Remove & Replace Curb Ramp With Two New Directional Ramps or Equivalent.

Total Cost: \$ 3200.00
