Access Compliance Report

Public Rights-of-Way

(Curb Ramps)

Intersection ID: 24093	Main Street: LIVINGSTON_MILL_RD	Cross Street: ROYALWOOD_LN	Location: NE
ADA ID: 233E0515625C	Ramp Type: PerpDiag	Initial Pass/Fail: Fail	Overall Compliance: No
Severity Score: 22.5			
Codes/Mitigation Info/Possible Solution		Field Measurements/Component Compliance

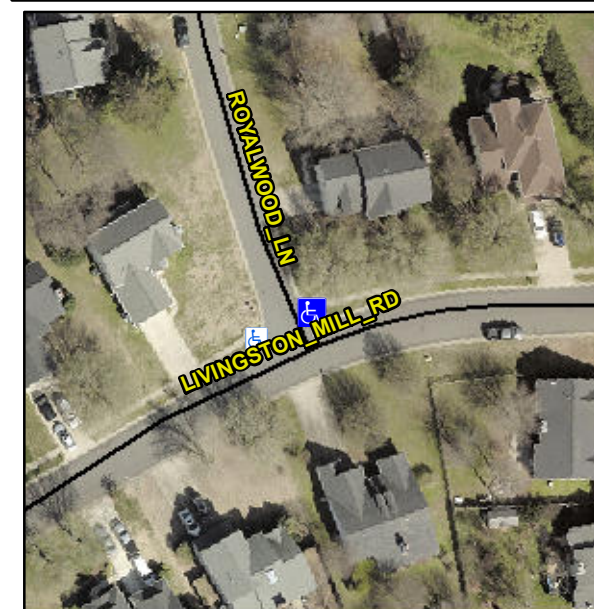
Compliance	Description	Data	Compliance	Description	Data
N/A	Ramp Length (in)	98.0	No	Ramp Slope (%)	9.5
No	Ramp Width (in)	47.0	No	Ramp XSlope (%)	5.0
N/A	Flare Type LT	N/A	N/A	Flare Type RT	N/A
N/A	Flare Slope LT (%)	N/A	N/A	Flare Slope RT (%)	N/A
N/A	Flare Traversable LT?	N/A	N/A	Flare Traversable RT?	N/A
N/A	Landing Length (in)	N/A	N/A	DWS Provided?	N/A
N/A	Landing Width (in)	N/A	N/A	DWS Contrast?	N/A
N/A	Landing Slope (%)	N/A	N/A	DWS Length (in)	N/A
N/A	Landing X Slope (%)	N/A	N/A	DWS Full Width?	N/A
N/A	Landing Curb? (Y/N)	N/A	N/A	DWS Offset (in)	N/A
N/A	Shared Landing?	N/A			
N/A	Gutter Ponding?	N/A	N/A	Gutter Slope (%)	N/A
N/A	Gutter Lip Ht (in)	N/A	N/A	Gutter X Slope (%)	N/A
N/A	Painted X Walk1?	No	N/A	Painted X Walk2?	No
	X Walk 1 Direction	To W		X Walk 2 Direction	To S
N/A	X Walk 1 Width (in)	N/A	N/A	X Walk 2 Width (in)	N/A
	X Walk 1 Slope (%)	1.4		X Walk 2 Slope (%)	3.8
	X Walk 1 X Slope (%)	2.6		X Walk 2 X Slope (%)	2.6

N/A	Ramp inside XWalk1?	N/A	N/A	Ramp inside XWalk2?	N/A
	Road Slope (%)	4.5	N/A	Clear Space?	N/A
	Road X Slope (%)	1.9	N/A	Clear Space to XWalk (in)	N/A
N/A	Any Obstructions?	N/A	N/A	Storm Grate/Utility Hazard?	N/A
	Obstruction Type			Storm Grate/Utility Type	
		N/A			N/A
			Yes	Surface Condition? (G/P)	Good

Remove & Replace Curb Ramp With Two New Directional Ramps or Equivalent.

R304.5.1, R304.2.2, R304.5.3
