# Access Compliance Report

## Public Rights-of-Way

### (Curb Ramps)

Intersection ID: 50928	Main Street: GREAT_FUTURE_DR	Cross Street: MARVIN_RD	Location: W
ADA ID: 2341BEF25DEB	Ramp Type: Perp	Initial Pass/Fail: Fail	Overall Compliance: No
Severity Score: 33.75			
Codes/Mitigation Info/Possible Solution		Field Measurements/Component Compliance

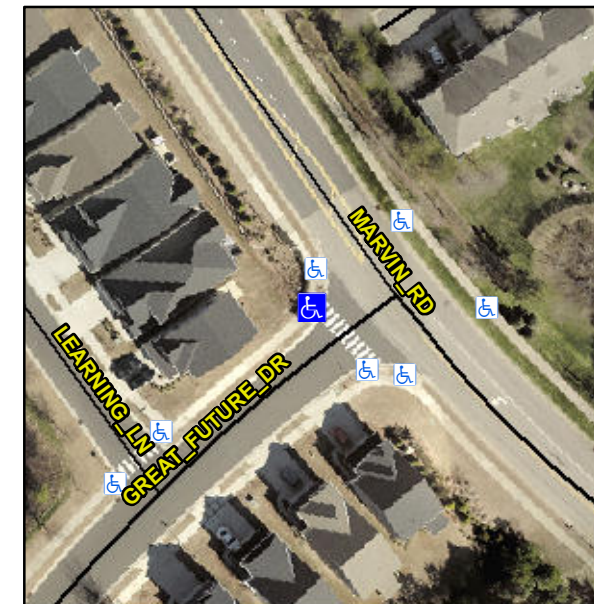
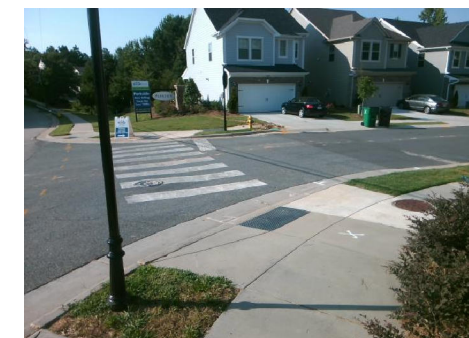
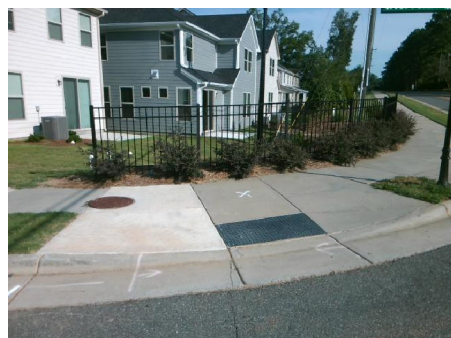
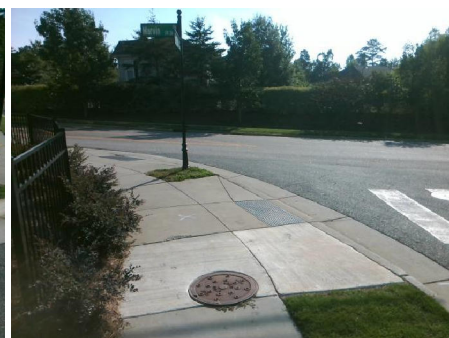
**Not Found, R304.5.1, R304.2.2, R304.5.3**

Compliance	Description	Data	Compliance	Description	Data
N/A	Ramp Length (in)	49.0	No	Ramp Slope (%)	9.5
No	Ramp Width (in)	47.5	No	Ramp XSlope (%)	5.5
N/A	Flare Type LT	N/A	N/A	Flare Type RT	N/A
N/A	Flare Slope LT (%)	N/A	N/A	Flare Slope RT (%)	N/A
N/A	Flare Traversable LT?	N/A	N/A	Flare Traversable RT?	N/A
N/A	Landing Length (in)	N/A	N/A	DWS Provided?	N/A
N/A	Landing Width (in)	N/A	N/A	DWS Contrast?	N/A
N/A	Landing Slope (%)	N/A	N/A	DWS Length (in)	N/A
N/A	Landing X Slope (%)	N/A	N/A	DWS Full Width?	N/A
N/A	Landing Curb? (Y/N)	N/A	N/A	DWS Offset (in)	N/A
N/A	Shared Landing?	N/A			
N/A	Gutter Ponding?	N/A	N/A	Gutter Slope (%)	N/A
N/A	Gutter Lip Ht (in)	N/A	N/A	Gutter X Slope (%)	N/A
N/A	Painted X Walk1?	Yes	N/A	Painted X Walk2?	N/A
	X Walk 1 Direction	To SE		X Walk 2 Direction	N/A
N/A	X Walk 1 Width (in)	120.0	N/A	X Walk 2 Width (in)	N/A
	X Walk 1 Slope (%)	3.2		X Walk 2 Slope (%)	N/A
	X Walk 1 X Slope (%)	2.1		X Walk 2 X Slope (%)	N/A

N/A	Ramp inside XWalk1?	Yes	N/A	Ramp inside XWalk2?	N/A
	Road Slope (%)	N/A	N/A	Clear Space?	N/A
	Road X Slope (%)	N/A	N/A	Clear Space to XWalk (in)	N/A
N/A	Any Obstructions?	N/A	N/A	Storm Grate/Utility Hazard?	N/A
	Obstruction Type			Storm Grate/Utility Type	
		N/A			N/A
			Yes	Surface Condition? (G/P)	Good

**Remove & Replace Entire Ramp.**

Total Cost: \$ 1850.00
