Intersection ID: 26096	Main Street: PARK_RD	Cross Street: BLUE_HERON_DR	Location:	NE
ADA ID: 235825FD5E04	Ramp Type: Perp	Initial Pass/Fail: Fail	Overall Compliance: No	Severity Score: 21.25

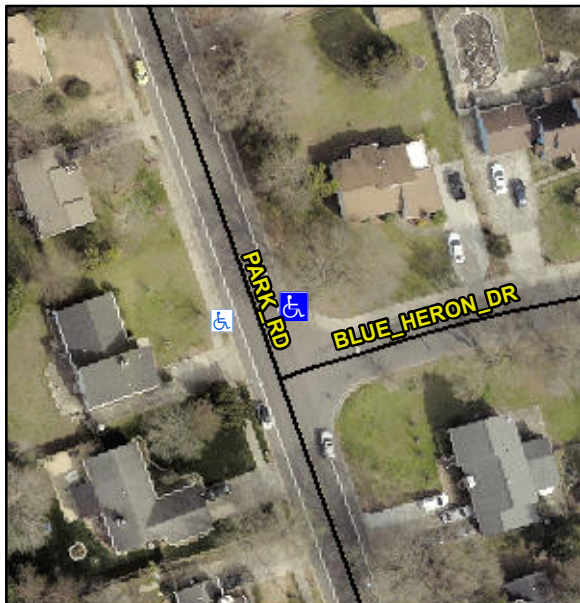
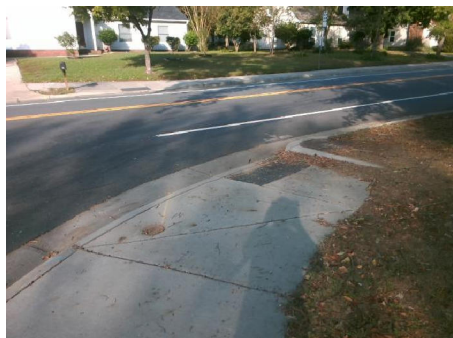
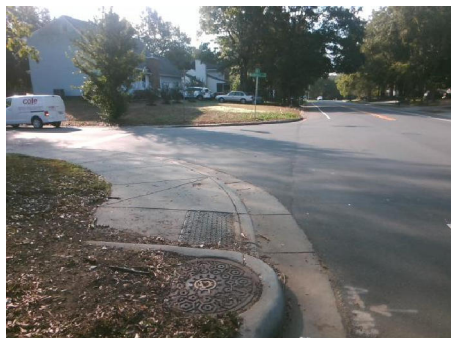
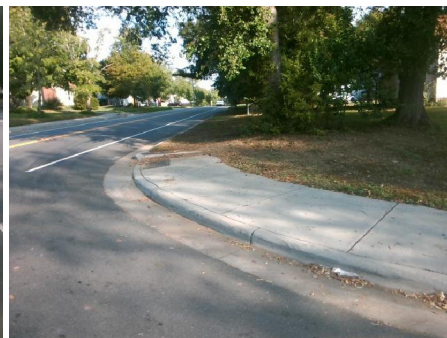
Possible Solutions:		Compliance	Description	Data	Compliance	Description	Data
	Remove & Replace Entire Ramp.		N/A	Ramp Length (in)	72.0	No	Ramp Slope (%)	9.5
			No	Ramp Width (in)	47.5	Yes	Ramp XSlope (%)	0.8
			N/A	Flare Type LT	N/A	N/A	Flare Type RT	N/A
			N/A	Flare Slope LT (%)	N/A	N/A	Flare Slope RT (%)	N/A
			N/A	Flare Traversable LT?	N/A	N/A	Flare Traversable RT?	N/A
			N/A	Landing Length (in)	N/A	N/A	DWS Provided?	N/A
			N/A	Landing Width (in)	N/A	N/A	DWS Contrast?	N/A
			N/A	Landing Slope (%)	N/A	N/A	DWS Length (in)	N/A
			N/A	Landing X Slope (%)	N/A	N/A	DWS Full Width?	N/A
Surveyor Notes:		N/A	N/A	Landing Curb? (Y/N)	N/A	N/A	DWS Offset (in)	N/A
PROW/ADA:		Not Found, R304.5.1, R304.2.2	N/A	Shared Landing?	N/A	N/A	Gutter Slope (%)	N/A
			N/A	Gutter Ponding?	N/A	N/A	Gutter X Slope (%)	N/A
			N/A	Gutter Lip Ht (in)	N/A	N/A	Painted X Walk2?	N/A

N/A	Painted X Walk1?	No	N/A	X Walk 2 Direction	N/A
				X Walk 1 Direction	To W		X Walk 2 Width (in)	N/A
			N/A	X Walk 1 Width (in)	N/A	N/A	X Walk 2 Slope (%)	N/A
				X Walk 1 Slope (%)	3.9		X Walk 2 X Slope (%)	N/A
				X Walk 1 X Slope (%)	2.0		Ramp inside XWalk2?	N/A
			N/A	Ramp inside XWalk1?	N/A	N/A	Clear Space?	N/A
				Road Slope (%)	N/A	N/A	Clear Space to XWalk (in)	N/A
				Road X Slope (%)	N/A	N/A	Storm Grate/Utility Hazard?	N/A
			N/A	Any Obstructions?	N/A	N/A	Storm Grate/Utility Type	
				Obstruction Type				
					N/A			N/A
						Yes	Surface Condition? (G/P)	Good
Street 1 Name	PARK RD							
Stop Condition-Street 2	None							
Street 2 Name	N/A							
Stop Condition-Street 1	N/A							
Total Cost:		\$ 1850.00
