# Access Compliance Report

## Public Rights-of-Way (Curb Ramps)

Intersection ID: 50602	Main Street: RHODORA_RD	Cross Street: CEDARFIELD_RD	Location: SE
ADA ID: 236952148274	Ramp Type: Perp	Initial Pass/Fail: Fail	Overall Compliance: No
		Severity Score: 35

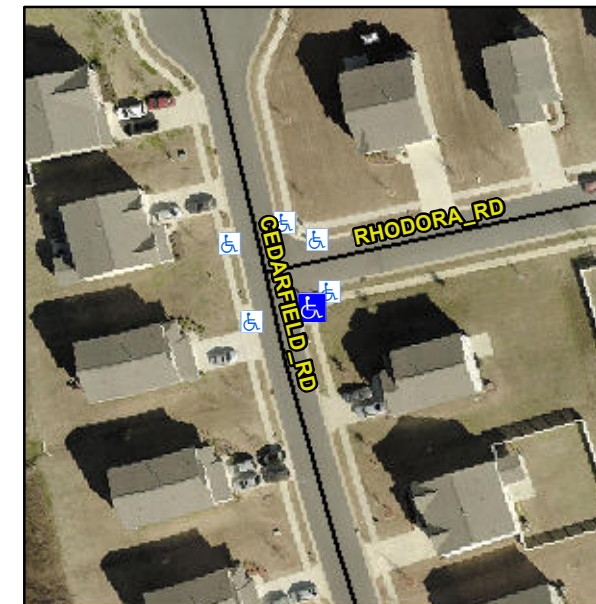
**Not Found, R304.5.1, R304.2.2, R304.5.3**

Compliance	Description	Data	Compliance	Description	Data
N/A	Ramp Length (in)	47.0	No	Ramp Slope (%)	15.7
No	Ramp Width (in)	47.5	No	Ramp XSlope (%)	2.6
N/A	Flare Type LT	N/A	N/A	Flare Type RT	N/A
N/A	Flare Slope LT (%)	N/A	N/A	Flare Slope RT (%)	N/A
N/A	Flare Traversable LT?	N/A	N/A	Flare Traversable RT?	N/A
N/A	Landing Length (in)	N/A	N/A	DWS Provided?	N/A
N/A	Landing Width (in)	N/A	N/A	DWS Contrast?	N/A
N/A	Landing Slope (%)	N/A	N/A	DWS Length (in)	N/A
N/A	Landing X Slope (%)	N/A	N/A	DWS Full Width?	N/A
N/A	Landing Curb? (Y/N)	N/A	N/A	DWS Offset (in)	N/A
N/A	Shared Landing?	N/A			
N/A	Gutter Ponding?	N/A	N/A	Gutter Slope (%)	N/A
N/A	Gutter Lip Ht (in)	N/A	N/A	Gutter X Slope (%)	N/A
N/A	Painted X Walk1?	No	N/A	Painted X Walk2?	N/A
	X Walk 1 Direction	To W		X Walk 2 Direction	N/A
N/A	X Walk 1 Width (in)	N/A	N/A	X Walk 2 Width (in)	N/A
	X Walk 1 Slope (%)	2.8		X Walk 2 Slope (%)	N/A
	X Walk 1 X Slope (%)	2.2		X Walk 2 X Slope (%)	N/A

N/A	Ramp inside XWalk1?	N/A	N/A	Ramp inside XWalk2?	N/A
	Road Slope (%)	N/A	N/A	Clear Space?	N/A
	Road X Slope (%)	N/A	N/A	Clear Space to XWalk (in)	N/A
N/A	Any Obstructions?	N/A	N/A	Storm Grate/Utility Hazard?	N/A
	Obstruction Type			Storm Grate/Utility Type	
		N/A			N/A
			Yes	Surface Condition? (G/P)	Good

**Remove & Replace Entire Ramp.**

Total Cost: \$ 1850.00
