| Intersection ID: 42739 | Main Street: CALDWELL_RIDGE_PY | Cross Street: LEES_CROSSING_DR | Location: | SW |
| ADA ID: 237D2FA98379 | Ramp Type: PerpDiag | Initial Pass/Fail: Fail | Overall Compliance: No | Severity Score: 10 |

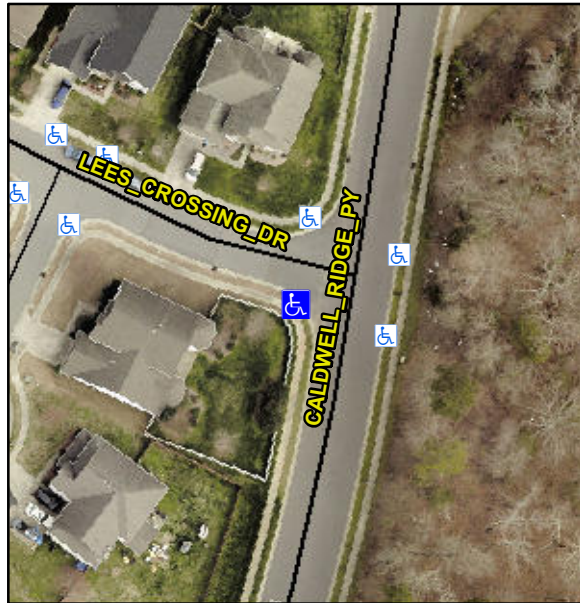
Not Found, R304.5.1, R304.5.3

| Compliance | Description | Data | Compliance | Description | Data |
|---|---|---|---|---|---|
| N/A | Ramp Length (in) | 46.5 | Yes | Ramp Slope (%) | 8.0 |
| No | Ramp Width (in) | 47.5 | No | Ramp XSlope (%) | 2.8 |

Remove & Replace Curb Ramp With Two New Directional Ramps or Equivalent.
