# Access Compliance Report

## Public Rights-of-Way

### (Curb Ramps)

Intersection ID: 7017	Main Street: MCALLISTER_DR	Cross Street: DAWNSHIRE_AV	Location: SW
ADA ID: 23B028B5D4C0	Ramp Type: Perp	Initial Pass/Fail: Fail	Overall Compliance: No
		Severity Score: 22.5

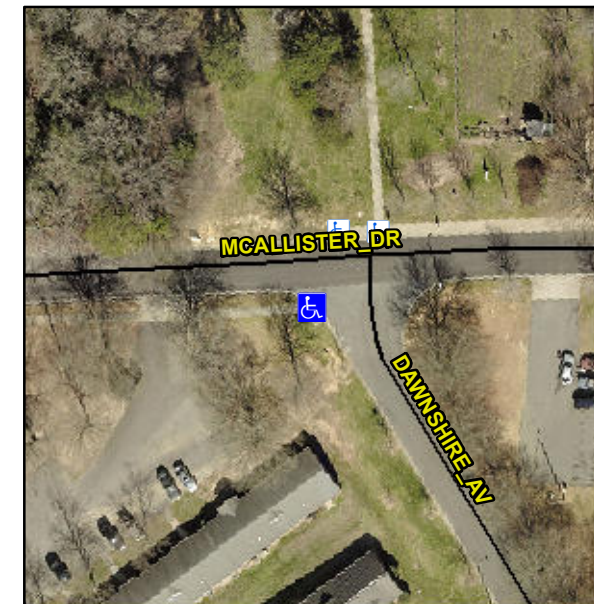
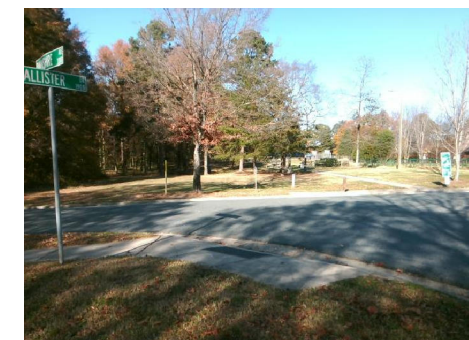
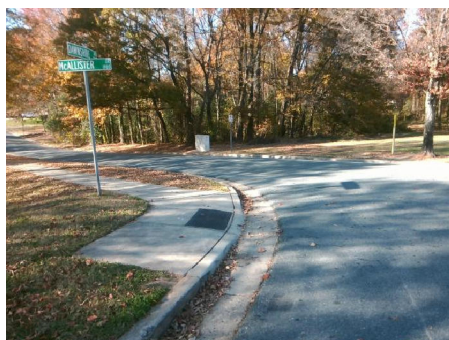
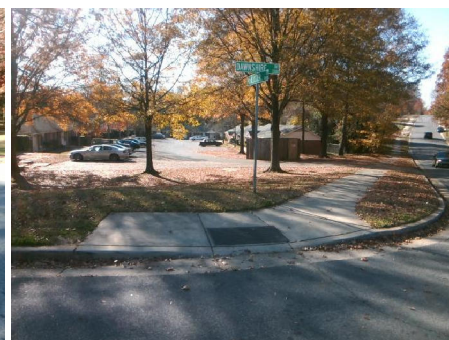
**Not Found, R304.5.1, R304.2.2, R304.5.3**

Compliance	Description	Data	Compliance	Description	Data
N/A	Ramp Length (in)	27.5	No	Ramp Slope (%)	9.9
No	Ramp Width (in)	44.5	No	Ramp XSlope (%)	4.7
N/A	Flare Type LT	N/A	N/A	Flare Type RT	N/A
N/A	Flare Slope LT (%)	N/A	N/A	Flare Slope RT (%)	N/A
N/A	Flare Traversable LT?	N/A	N/A	Flare Traversable RT?	N/A
N/A	Landing Length (in)	N/A	N/A	DWS Provided?	N/A
N/A	Landing Width (in)	N/A	N/A	DWS Contrast?	N/A
N/A	Landing Slope (%)	N/A	N/A	DWS Length (in)	N/A
N/A	Landing X Slope (%)	N/A	N/A	DWS Full Width?	N/A
N/A	Landing Curb? (Y/N)	N/A	N/A	DWS Offset (in)	N/A
N/A	Shared Landing?	N/A			
N/A	Gutter Ponding?	N/A	N/A	Gutter Slope (%)	N/A
N/A	Gutter Lip Ht (in)	N/A	N/A	Gutter X Slope (%)	N/A
N/A	Painted X Walk1?	No	N/A	Painted X Walk2?	N/A
	X Walk 1 Direction	To NE		X Walk 2 Direction	N/A
N/A	X Walk 1 Width (in)	N/A	N/A	X Walk 2 Width (in)	N/A
	X Walk 1 Slope (%)	1.8		X Walk 2 Slope (%)	N/A
	X Walk 1 X Slope (%)	3.5		X Walk 2 X Slope (%)	N/A

**Remove & Replace Entire Ramp.**
