# Access Compliance Report

## Public Rights-of-Way

### (Curb Ramps)

Intersection ID: 20516	Main Street: OLD_PINEVILLE_RD	Cross Street: SILVERLEAF_RD	Location: NW
ADA ID: 23BB591475A6	Ramp Type: Directional1	Initial Pass/Fail: Fail	Overall Compliance: No
Severity Score: 12.5			
Codes/Mitigation Info/Possible Solution		Field Measurements/Component Compliance

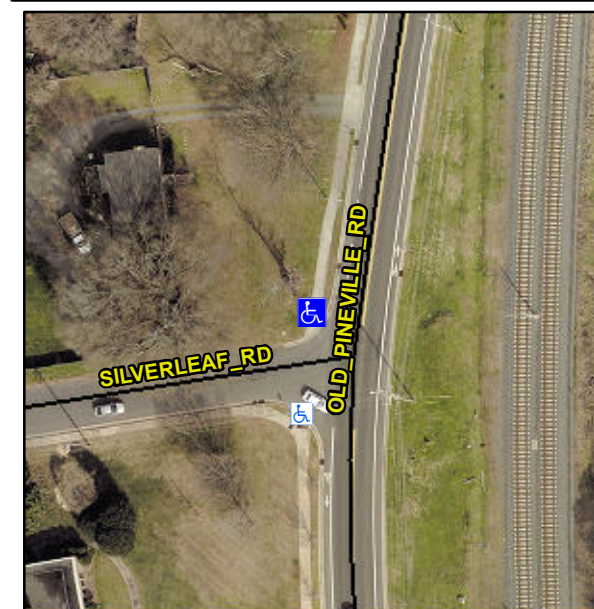
Compliance	Description	Data	Compliance	Description	Data
N/A	Ramp Length (in)	79.0	N/A	Grade Break?	N/A
Yes	Ramp Width (in)	69.0	N/A	Grade Break Slope (%)	0.0
Yes	Ramp Slope (%)	3.9	N/A	Grade Break XSlope (%)	0.0
No	Ramp XSlope (%)	5.7			
N/A	Flare Type LT	N/A	N/A	Flare Type RT	N/A
N/A	Flare Slope LT (%)	N/A	N/A	Flare Slope RT (%)	0.0
N/A	Flare Traversable LT?	N/A	N/A	Flare Traversable RT?	N/A
N/A	Landing Length (in)	0.0	N/A	DWS Provided?	N/A
N/A	Landing Width (in)	0.0	N/A	DWS Contrast?	N/A
N/A	Landing Slope (%)	0.0	N/A	DWS Length (in)	N/A
N/A	Landing X Slope (%)	0.0	N/A	DWS Full Width?	N/A
N/A	Landing Curb? (Y/N)	N/A	N/A	DWS Offset LT (in)	N/A
N/A	Shared Landing?	N/A	N/A	DWS Offset RT (in)	N/A
N/A	Gutter Ponding?	0.0	N/A	Gutter Slope (%)	N/A
N/A	Gutter Lip Ht (in)	0.0	N/A	Gutter X Slope (%)	N/A
N/A	Painted X Walk1?	No		Road Slope (%)	4.2
	X Walk 1 Direction	To S		Road X Slope (%)	2.4
	X Walk 1 Width (in)	N/A		Clear Space?	N/A

X Walk 1 Slope (%)	4.2	N/A	Clear Space to XWalk (in)	N/A
	X Walk 1 X Slope (%)	2.4	N/A	Storm Grate/Utility Hazard?	N/A
N/A	Ramp inside XWalk1?	N/A		Storm Grate/Utility Type	
N/A	Any Obstructions?	N/A			N/A
	Obstruction Type		Yes	Surface Condition? (G/P)	Good
			N/A	Curb Slope (%)	16.2

Possible Solutions:

**Remove & Replace Entire Ramp.**

**R304.5.3**

Total Cost: \$ 1600.00

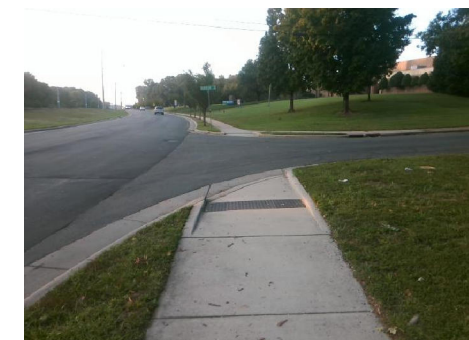
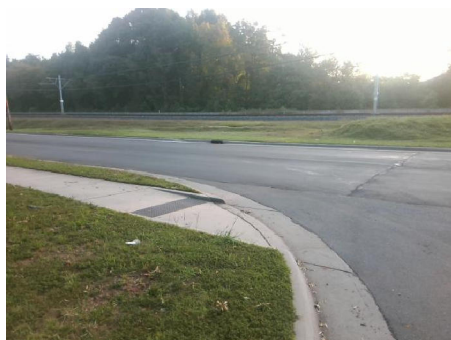
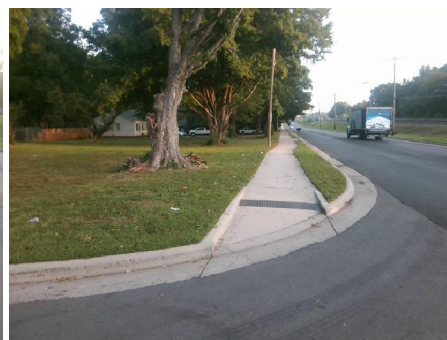
Street 1 Name	SILVERLEAF RD
Stop Condition-Street 1	StopSign
Street 2 Name	N/A
Stop Condition-Street 2	N/A
