# Access Compliance Report

## Public Rights-of-Way

### (Curb Ramps)

Intersection ID: 53096	Main Street: BRODIE LN	Cross Street: DIXIE RIVER RD	Location: SW
ADA ID: 23C331F4AC81	Ramp Type: BlendTrans1	Initial Pass/Fail: Fail	Overall Compliance: No
		Severity Score: 10

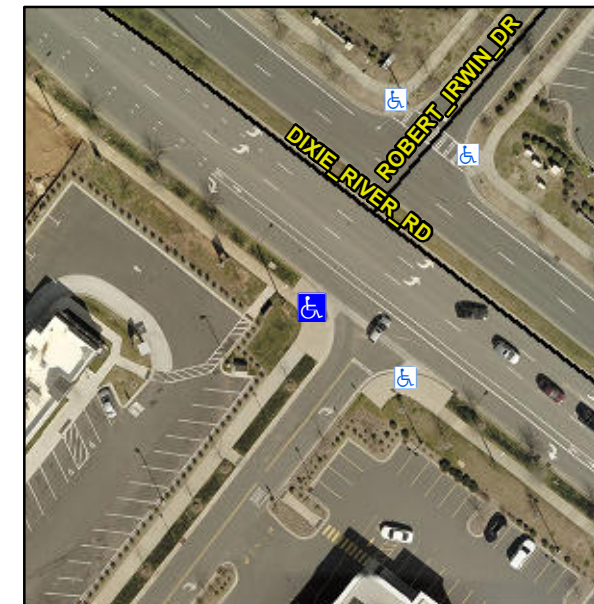
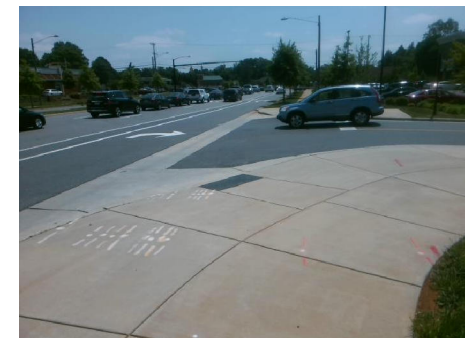
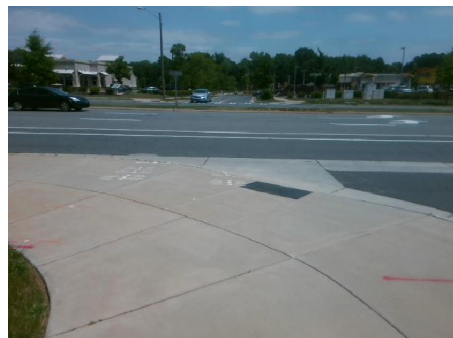
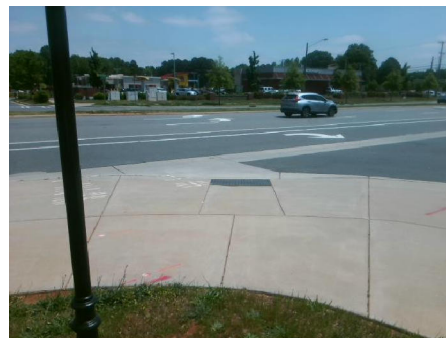
**MEDIAN ACROSS DIXIE RIVER RD**

**Not Found, R304.5.1, R304.5.3**

Compliance	Description	Data	Compliance	Description	Data
N/A	Ramp Length (in)	97.0	Yes	BlendTrans Slope (%)	4.5
No	Ramp Width (in)	46.5	No	BlendTrans XSlope (%)	2.7
N/A	Flare Type LT	N/A	N/A	Flare Type RT	N/A
N/A	Flare Slope LT (%)	N/A	N/A	Flare Slope RT (%)	N/A
N/A	Flare Traversable LT?	N/A	N/A	Flare Traversable RT?	N/A
N/A	Landing Length (in)	N/A	N/A	DWS Provided?	N/A
N/A	Landing Width (in)	N/A	N/A	DWS Contrast?	N/A
N/A	Landing Slope (%)	N/A	N/A	DWS Length (in)	N/A
N/A	Landing X Slope (%)	N/A	N/A	DWS Full Width?	N/A
N/A	Landing Curb? (Y/N)	N/A	N/A	DWS Offset (in)	N/A
N/A	Shared Landing?	N/A			
N/A	Gutter Ponding?	N/A	N/A	Gutter Slope (%)	N/A
N/A	Gutter Lip Ht (in)	N/A	N/A	Gutter X Slope (%)	N/A
N/A	Painted X Walk1?	No	N/A	Painted X Walk2?	No
	X Walk 1 Direction	To SE		X Walk 2 Direction	To NE
	X Walk 1 Width (in)	N/A		X Walk 2 Width (in)	N/A
	X Walk 1 Slope (%)	4.6		X Walk 2 Slope (%)	1.3
	X Walk 1 X Slope (%)	1.7		X Walk 2 X Slope (%)	0.6

N/A	Ramp inside XWalk1?	N/A	N/A	Ramp inside XWalk2?	N/A
	Road Slope (%)	0.7		Clear Space?	N/A
	Road X Slope (%)	2.5	N/A	Clear Space to XWalk (in)	N/A
N/A	Any Obstructions?	N/A	N/A	Storm Grate/Utility Hazard?	N/A
	Obstruction Type			Storm Grate/Utility Type	
		N/A			N/A
			Yes	Surface Condition? (G/P)	Good
			No	Curb Slope (%)	11.2

**Remove & Replace Curb Ramp With Two New Directional Ramps or Equivalent.**
