# Access Compliance Report

## Public Rights-of-Way

### (Curb Ramps)

Intersection ID: 43093	Main Street: N_POPLAR_ST	Cross Street: W_10TH_ST	Location: E
ADA ID: 23C456D2A84C	Ramp Type: PerpDiag	Initial Pass/Fail: Fail	Overall Compliance: No
			Severity Score: 21.25

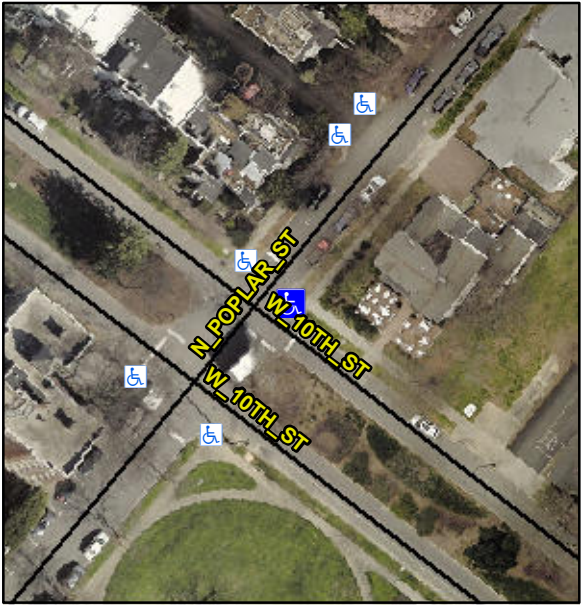
Possible Solutions:		<b>Compliance</b>	<b>Description</b>	<b>Data</b>
	<b>Remove &amp; Replace Curb Ramp With Two New Directional Ramps or Equivalent.</b>		<b>Yes</b>	Ramp Length (in)	92.0
			<b>No</b>	Ramp Width (in)	45.0
			<b>N/A</b>	Flare Type LT	N/A
			<b>N/A</b>	Flare Slope LT (%)	N/A
			<b>N/A</b>	Flare Traversable LT?	N/A
			<b>N/A</b>	Landing Length (in)	N/A
			<b>N/A</b>	Landing Width (in)	N/A
			<b>N/A</b>	Landing Slope (%)	N/A
			<b>N/A</b>	Landing X Slope (%)	N/A
<p>Surveyor Notes:</p> <p><b>N/A</b></p> <p>PROW/ADA:</p> <p><b>R304.5.1, R304.5.3</b></p>			<b>N/A</b>	Flare Type RT	N/A
			<b>N/A</b>	Flare Slope RT (%)	N/A
			<b>N/A</b>	Flare Traversable RT?	N/A
			<b>N/A</b>	DWS Provided?	N/A
			<b>N/A</b>	DWS Contrast?	N/A
			<b>N/A</b>	DWS Length (in)	N/A
			<b>N/A</b>	DWS Full Width?	N/A
			<b>N/A</b>	DWS Offset (in)	N/A

<b>N/A</b>	Shared Landing?	N/A
			<b>N/A</b>	Gutter Ponding?	N/A
			<b>N/A</b>	Gutter Lip Ht (in)	N/A
			<b>N/A</b>	Painted X Walk1?	No
				X Walk 1 Direction	To NW
			<b>N/A</b>	X Walk 1 Width (in)	N/A
				X Walk 1 Slope (%)	2.5
				X Walk 1 X Slope (%)	6.4
			<b>N/A</b>	Ramp inside XWalk1?	N/A
				Road Slope (%)	5.1
				Road X Slope (%)	10.7
			<b>N/A</b>	Any Obstructions?	N/A
				Obstruction Type	
Total Cost:		\$ 3200.00			
			<b>N/A</b>		N/A
			<b>Yes</b>	Surface Condition? (G/P)	Good
