Access Compliance Report Public Rights-of-Way (Curb Ramps)

Intersection ID: 11070
 Main Street: CAMP_GREENE_ST
 Cross Street: AMBER_DR
 Location:
 W

ADA ID: 23CCAECECB11
 Ramp Type: Perp
 Initial Pass/Fail: Fail
 Overall Compliance: No
 Severity Score: 36.25

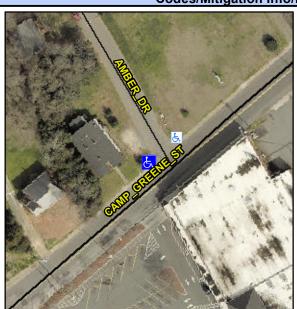
Not Found, R304.5.1, R304.5.3

| Field Measurements/Component Compilance | | | | | |
|---|---|---|---|---|---|
| No | Ramp Width (in) | 31.0 | No | Ramp XSlope (%) | 2.5 |
| N/A | Gutter Ponding? | Yes | N/A | Gutter Slope (%) | N/A |

Remove & Replace Entire Ramp.

Total Cost: \$ 1850.00
