Access Compliance Report

Public Rights-of-Way (Curb Ramps)

Intersection ID: 10014712	Main Street: NORLAND_RD	Cross Street: N/A	Location:	N
ADA ID: 23D556704A2F	Ramp Type: PerpDiag	Initial Pass/Fail: Fail	Overall Compliance: No	Severity Score: 12.5
Codes/Mitigation Info/Possible Solution		Field Measurements/Component Compliance

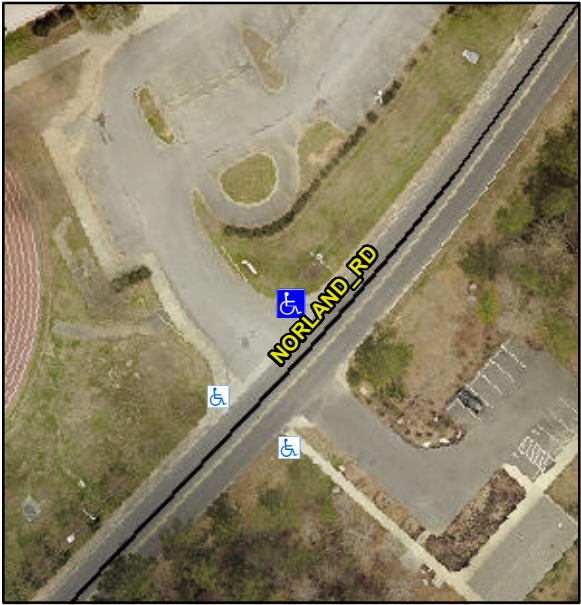
Possible Solutions:						
	Remove & Replace Curb Ramp With Two New Directional Ramps or Equivalent.	Compliance	Description	Data	Compliance	Description	Data
<p>Surveyor Notes:</p> <p>N/A</p> <p>PROW/ADA:</p> <p>R304.2.2</p>		N/A	Ramp Length (in)	47.0	No	Ramp Slope (%)	10.6
		Yes	Ramp Width (in)	49.0	Yes	Ramp XSlope (%)	1.3
<p>Street 1 Name</p> <p>ENTRANCE</p> <p>Stop Condition-Street 2</p> <p>None</p> <p>Street 2 Name</p> <p>NORLAND RD</p> <p>Stop Condition-Street 1</p> <p>None</p>		N/A	Flare Type LT	N/A	N/A	Flare Type RT	N/A
		N/A	Flare Slope LT (%)	N/A	N/A	Flare Slope RT (%)	N/A
<p>Total Cost:</p> <p>\$ 3200.00</p>		N/A	Flare Traversable LT?	N/A	N/A	Flare Traversable RT?	N/A
		N/A	Landing Length (in)	N/A	N/A	DWS Provided?	N/A
		N/A	Landing Width (in)	N/A	N/A	DWS Contrast?	N/A
		N/A	Landing Slope (%)	N/A	N/A	DWS Length (in)	N/A
		N/A	Landing X Slope (%)	N/A	N/A	DWS Full Width?	N/A
		N/A	Landing Curb? (Y/N)	N/A	N/A	DWS Offset (in)	N/A

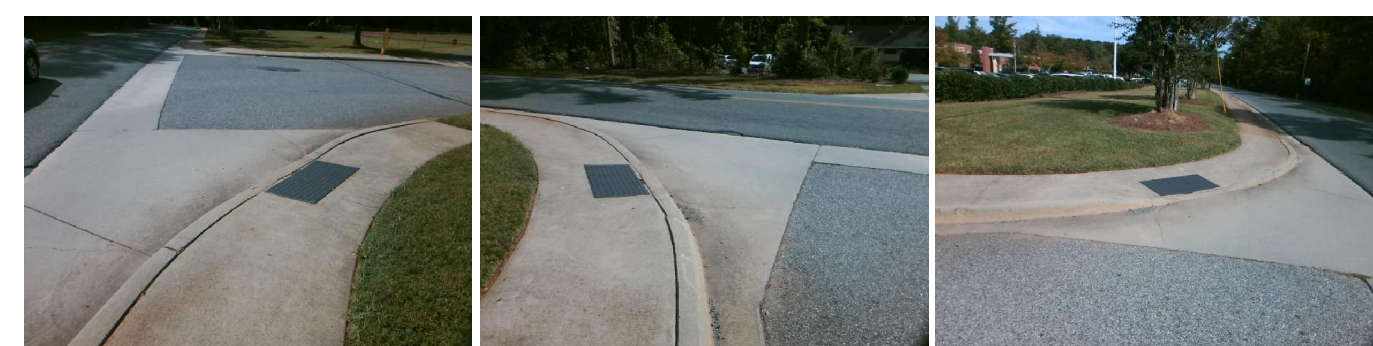
N/A	Shared Landing?	N/A			
		N/A	Gutter Ponding?	N/A	N/A	Gutter Slope (%)	N/A
		N/A	Gutter Lip Ht (in)	N/A	N/A	Gutter X Slope (%)	N/A
		N/A	Painted X Walk1?	No	N/A	Painted X Walk2?	No
			X Walk 1 Direction	To SW		X Walk 2 Direction	To SE
		N/A	X Walk 1 Width (in)	N/A	N/A	X Walk 2 Width (in)	N/A
			X Walk 1 Slope (%)	1.0		X Walk 2 Slope (%)	1.7
			X Walk 1 X Slope (%)	1.2		X Walk 2 X Slope (%)	1.2
		N/A	Ramp inside XWalk1?	N/A	N/A	Ramp inside XWalk2?	N/A
			Road Slope (%)	0.7	N/A	Clear Space?	N/A
			Road X Slope (%)	2.3	N/A	Clear Space to XWalk (in)	N/A
		N/A	Any Obstructions?	N/A	N/A	Storm Grate/Utility Hazard?	N/A
			Obstruction Type			Storm Grate/Utility Type	
				N/A			N/A
					Yes	Surface Condition? (G/P)	Good
