Access Compliance Report

(Curb Ramps)

Intersection ID: 10038838	Main Street: STEELECROFT_PY	Cross Street: N/A	Location: E
ADA ID: 23D9C68E2D7A	Ramp Type: PerpDiag	Initial Pass/Fail: Fail	Overall Compliance: No
Severity Score: 21.25			
Codes/Mitigation Info/Possible Solution		Field Measurements/Component Compliance

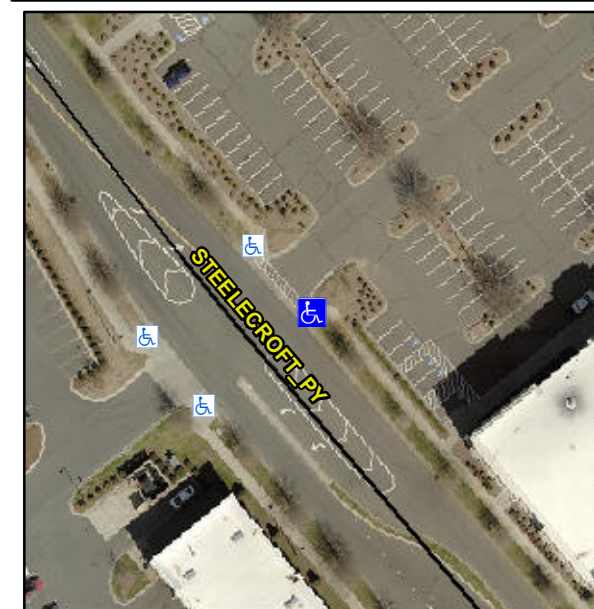
Not Found, R304.5.1, R304.2.2

Compliance	Description	Data	Compliance	Description	Data
N/A	Ramp Length (in)	99.0	No	Ramp Slope (%)	9.1
No	Ramp Width (in)	42.5	Yes	Ramp XSlope (%)	0.7
N/A	Flare Type LT	N/A	N/A	Flare Type RT	N/A
N/A	Flare Slope LT (%)	N/A	N/A	Flare Slope RT (%)	N/A
N/A	Flare Traversable LT?	N/A	N/A	Flare Traversable RT?	N/A
N/A	Landing Length (in)	N/A	N/A	DWS Provided?	N/A
N/A	Landing Width (in)	N/A	N/A	DWS Contrast?	N/A
N/A	Landing Slope (%)	N/A	N/A	DWS Length (in)	N/A
N/A	Landing X Slope (%)	N/A	N/A	DWS Full Width?	N/A
N/A	Landing Curb? (Y/N)	N/A	N/A	DWS Offset (in)	N/A
N/A	Shared Landing?	N/A			
N/A	Gutter Ponding?	N/A	N/A	Gutter Slope (%)	N/A
N/A	Gutter Lip Ht (in)	N/A	N/A	Gutter X Slope (%)	N/A
N/A	Painted X Walk1?	Yes	N/A	Painted X Walk2?	No
	X Walk 1 Direction	To NW		X Walk 2 Direction	To SW
N/A	X Walk 1 Width (in)	52.0	N/A	X Walk 2 Width (in)	N/A
	X Walk 1 Slope (%)	0.7		X Walk 2 Slope (%)	0.8
	X Walk 1 X Slope (%)	2.9		X Walk 2 X Slope (%)	0.5

N/A	Ramp inside XWalk1?	Yes	N/A	Ramp inside XWalk2?	N/A
	Road Slope (%)	0.5	N/A	Clear Space?	N/A
	Road X Slope (%)	1.9	N/A	Clear Space to XWalk (in)	N/A
N/A	Any Obstructions?	N/A	N/A	Storm Grate/Utility Hazard?	N/A
	Obstruction Type			Storm Grate/Utility Type	
		N/A			N/A
		Yes		Surface Condition? (G/P)	Good

Remove & Replace Curb Ramp With Two New Directional Ramps or Equivalent.

Total Cost: \$ 3200.00
