## **Access Compliance Report Public Rights-of-Way** (Curb Ramps)

Intersection ID: 12828 Main Street: W MOREHEAD ST **Cross Street: S CHURCH ST** Location: SW **Overall Compliance: No** ADA ID: 23E2B643AA71 Ramp Type: PerpDiag Initial Pass/Fail: Fail **Severity Score:** 22.5

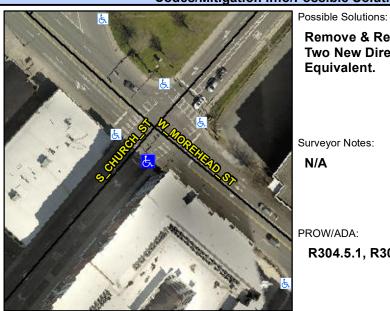
Comp	liance Description	Data	Comp	liance	Description	Data
N/A	Ramp Length (in)	91.0	No	Ram	Slope (%)	9.3
No	Ramp Width (in)	38.0	Yes	Ram	XSlope (%)	2.5
N/A	Flare Type LT	N/A	N/A	Flare	Type RT	N/A
N/A	Flare Slope LT (%)	N/A	N/A	Flare	Slope RT (%)	N/A
N/A	Flare Traversable LT?	N/A	N/A	Flare	Traversable RT?	N/A
N/A	Landing Length (in)	N/A	N/A	DWS	Provided?	N/A
N/A	Landing Width (in)	N/A	N/A	DWS	Contrast?	N/A
N/A	Landing Slope (%)	N/A	N/A	DWS	Length (in)	N/A
N/A	Landing X Slope (%)	N/A	N/A	DWS	Full Width?	N/A
N/A	Landing Curb? (Y/N)	N/A	N/A	DWS	Offset (in)	N/A
N/A	Shared Landing?	N/A				
N/A	Gutter Ponding?	N/A	N/A	Gutte	er Slope (%)	N/A
N/A	Gutter Lip Ht (in)	N/A	N/A	Gutte	er X Slope (%)	N/A
N/A	Painted X Walk1?	Yes	N/A	Paint	ed X Walk2?	Yes
	X Walk 1 Direction	To NE		X Wa	lk 2 Direction	To NW
N/A	X Walk 1 Width (in)	99.0	N/A	X Wa	lk 2 Width (in)	87.0
	X Walk 1 Slope (%)	5.8		X Wa	lk 2 Slope (%)	2.0
	X Walk 1 X Slope (%)	0.4		X Wa	lk 2 X Slope (%)	8.3

N/A	Ramp inside XWalk1?	Yes	N/A	Ram	inside XWalk2?	Yes
	Road Slope (%)	7.3	N/A	Clear	Space?	N/A
	Road X Slope (%)	6.6	N/A	Clear	Space to XWalk (in)	N/A
N/A	Any Obstructions?	N/A	N/A	Storn	n Grate/Utility Hazard?	N/A
	Obstruction Type			Storn	n Grate/Utility Type	
		N/A				N/A
			Yes	Surfa	ce Condition? (G/P)	Good

**Remove & Replace Curb Ramp With Two New Directional Ramps or** Equivalent.

R304.5.1, R304.2.2
