Access Compliance Report

Public Rights-of-Way

(Curb Ramps)

Intersection ID: 29700	Main Street: CAMERON_CREEK_DR	Cross Street: WEDDINGTON_RIDGE_LN	Location: S
ADA ID: 23E99B428A7A	Ramp Type: Perp	Initial Pass/Fail: Fail	Overall Compliance: No
Severity Score: 12.5			
Codes/Mitigation Info/Possible Solution		Field Measurements/Component Compliance

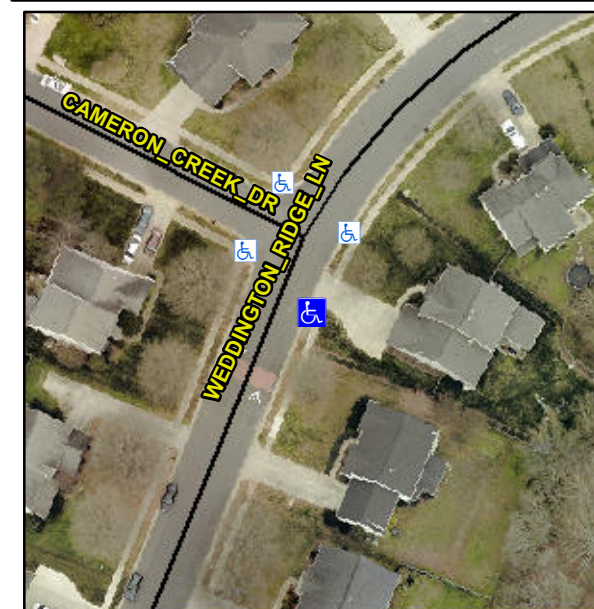
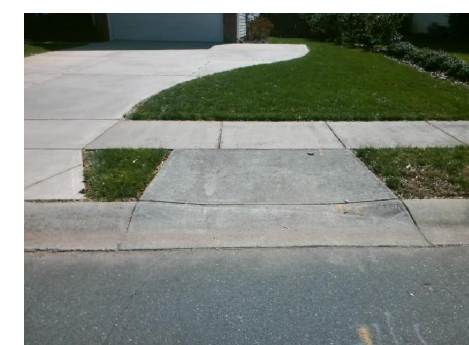
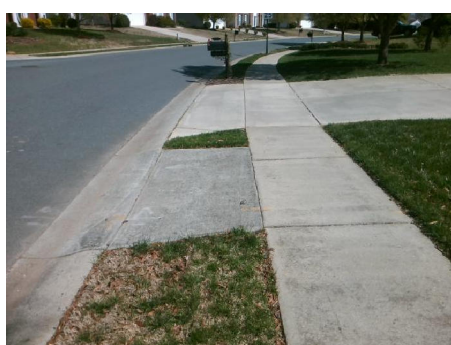
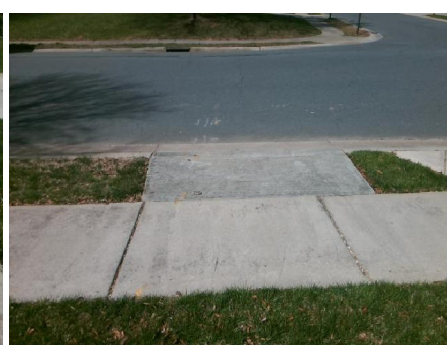
Not Found, R304.2.2

Compliance	Description	Data	Compliance	Description	Data
N/A	Ramp Length (in)	48.0	No	Ramp Slope (%)	10.7
Yes	Ramp Width (in)	48.0	Yes	Ramp XSlope (%)	0.6
N/A	Flare Type LT	N/A	N/A	Flare Type RT	N/A
N/A	Flare Slope LT (%)	N/A	N/A	Flare Slope RT (%)	N/A
N/A	Flare Traversable LT?	N/A	N/A	Flare Traversable RT?	N/A
N/A	Landing Length (in)	N/A	N/A	DWS Provided?	N/A
N/A	Landing Width (in)	N/A	N/A	DWS Contrast?	N/A
N/A	Landing Slope (%)	N/A	N/A	DWS Length (in)	N/A
N/A	Landing X Slope (%)	N/A	N/A	DWS Full Width?	N/A
N/A	Landing Curb? (Y/N)	N/A	N/A	DWS Offset (in)	N/A
N/A	Shared Landing?	N/A			
N/A	Gutter Ponding?	N/A	N/A	Gutter Slope (%)	N/A
N/A	Gutter Lip Ht (in)	N/A	N/A	Gutter X Slope (%)	N/A
N/A	Painted X Walk1?	No	N/A	Painted X Walk2?	N/A
	X Walk 1 Direction	To NW		X Walk 2 Direction	N/A
N/A	X Walk 1 Width (in)	N/A	N/A	X Walk 2 Width (in)	N/A
	X Walk 1 Slope (%)	3.9		X Walk 2 Slope (%)	N/A
	X Walk 1 X Slope (%)	0.8		X Walk 2 X Slope (%)	N/A

N/A	Ramp inside XWalk1?	N/A	N/A	Ramp inside XWalk2?	N/A
	Road Slope (%)	N/A	N/A	Clear Space?	N/A
	Road X Slope (%)	N/A	N/A	Clear Space to XWalk (in)	N/A
N/A	Any Obstructions?	N/A	N/A	Storm Grate/Utility Hazard?	N/A
	Obstruction Type			Storm Grate/Utility Type	
		N/A			N/A
			Yes	Surface Condition? (G/P)	Good

Remove & Replace Entire Ramp.
