Access Compliance Report

Public Rights-of-Way

(Curb Ramps)

Intersection ID: 6787	Main Street: N_GRAHAM_ST	Cross Street: PRINCESS_ST	Location: E
ADA ID: 23F8BB15B4FF	Ramp Type: Perp	Initial Pass/Fail: Fail	Overall Compliance: No
Severity Score: 21.25			
Codes/Mitigation Info/Possible Solution		Field Measurements/Component Compliance

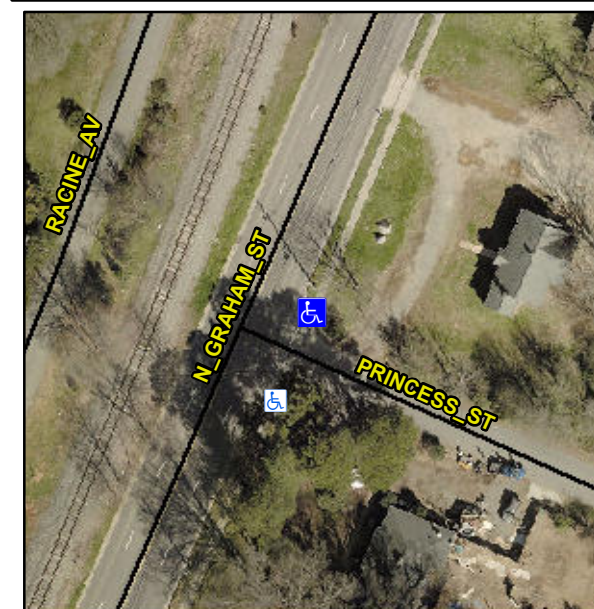
Not Found, R304.5.1, R304.2.2

Compliance	Description	Data	Compliance	Description	Data
N/A	Ramp Length (in)	41.0	No	Ramp Slope (%)	8.4
No	Ramp Width (in)	43.5	Yes	Ramp XSlope (%)	0.5
N/A	Flare Type LT	N/A	N/A	Flare Type RT	N/A
N/A	Flare Slope LT (%)	N/A	N/A	Flare Slope RT (%)	N/A
N/A	Flare Traversable LT?	N/A	N/A	Flare Traversable RT?	N/A
N/A	Landing Length (in)	N/A	N/A	DWS Provided?	N/A
N/A	Landing Width (in)	N/A	N/A	DWS Contrast?	N/A
N/A	Landing Slope (%)	N/A	N/A	DWS Length (in)	N/A
N/A	Landing X Slope (%)	N/A	N/A	DWS Full Width?	N/A
N/A	Landing Curb? (Y/N)	N/A	N/A	DWS Offset (in)	N/A
N/A	Shared Landing?	N/A			
N/A	Gutter Ponding?	Yes	N/A	Gutter Slope (%)	N/A
N/A	Gutter Lip Ht (in)	N/A	N/A	Gutter X Slope (%)	N/A
N/A	Painted X Walk1?	No	N/A	Painted X Walk2?	N/A
	X Walk 1 Direction	To SW		X Walk 2 Direction	N/A
N/A	X Walk 1 Width (in)	N/A	N/A	X Walk 2 Width (in)	N/A
	X Walk 1 Slope (%)	1.9		X Walk 2 Slope (%)	N/A
	X Walk 1 X Slope (%)	1.5		X Walk 2 X Slope (%)	N/A

N/A	Ramp inside XWalk1?	N/A	N/A	Ramp inside XWalk2?	N/A
	Road Slope (%)	N/A	N/A	Clear Space?	N/A
	Road X Slope (%)	N/A	N/A	Clear Space to XWalk (in)	N/A
N/A	Any Obstructions?	N/A	N/A	Storm Grate/Utility Hazard?	N/A
	Obstruction Type			Storm Grate/Utility Type	
		N/A			N/A
		Yes		Surface Condition? (G/P)	Good

Possible Solutions:

Remove & Replace Entire Ramp.

Total Cost: \$ 1850.00
