Access Compliance Report

Public Rights-of-Way

(Curb Ramps)

Intersection ID: 14469	Main Street: E_MOREHEAD_ST	Cross Street: KENILWORTH_AV	Location: W
ADA ID: 23FF5C337543	Ramp Type: PerpDiag	Initial Pass/Fail: Fail	Overall Compliance: No
Severity Score: 12.5			
Codes/Mitigation Info/Possible Solution		Field Measurements/Component Compliance

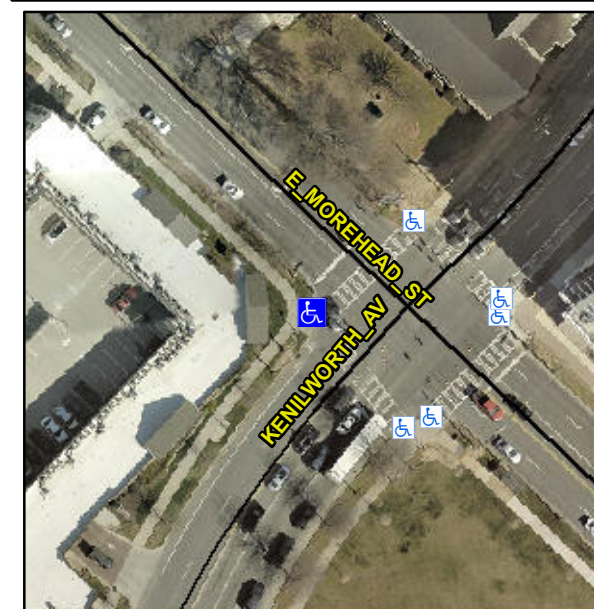
Compliance	Description	Data	Compliance	Description	Data
N/A	Ramp Length (in)	96.0	No	Ramp Slope (%)	8.5
Yes	Ramp Width (in)	48.0	Yes	Ramp XSlope (%)	1.9
N/A	Flare Type LT	N/A	N/A	Flare Type RT	N/A
N/A	Flare Slope LT (%)	N/A	N/A	Flare Slope RT (%)	N/A
N/A	Flare Traversable LT?	N/A	N/A	Flare Traversable RT?	N/A
N/A	Landing Length (in)	N/A	N/A	DWS Provided?	N/A
N/A	Landing Width (in)	N/A	N/A	DWS Contrast?	N/A
N/A	Landing Slope (%)	N/A	N/A	DWS Length (in)	N/A
N/A	Landing X Slope (%)	N/A	N/A	DWS Full Width?	N/A
N/A	Landing Curb? (Y/N)	N/A	N/A	DWS Offset (in)	N/A
N/A	Shared Landing?	N/A			
N/A	Gutter Ponding?	N/A	N/A	Gutter Slope (%)	N/A
N/A	Gutter Lip Ht (in)	N/A	N/A	Gutter X Slope (%)	N/A
N/A	Painted X Walk1?	Yes	N/A	Painted X Walk2?	Yes
	X Walk 1 Direction	To SE		X Walk 2 Direction	To NE
N/A	X Walk 1 Width (in)	120.0	N/A	X Walk 2 Width (in)	111.0
	X Walk 1 Slope (%)	3.6		X Walk 2 Slope (%)	0.5
	X Walk 1 X Slope (%)	2.0		X Walk 2 X Slope (%)	1.6

N/A	Ramp inside XWalk1?	Yes	N/A	Ramp inside XWalk2?	Yes
	Road Slope (%)	1.6	N/A	Clear Space?	N/A
	Road X Slope (%)	4.2	N/A	Clear Space to XWalk (in)	N/A
N/A	Any Obstructions?	N/A	N/A	Storm Grate/Utility Hazard?	N/A
	Obstruction Type			Storm Grate/Utility Type	
		N/A			N/A
		Yes		Surface Condition? (G/P)	Good

Possible Solutions:

Remove & Replace Curb Ramp With Two New Directional Ramps or Equivalent.

R304.2.2
