Access Compliance Report

Public Rights-of-Way

(Curb Ramps)

Intersection ID: 31209	Main Street: CAPRINGTON_AV	Cross Street: CLACKWYCK_LN	Location: E
ADA ID: 24082760B863	Ramp Type: PerpDiag	Initial Pass/Fail: Fail	Overall Compliance: No
			Severity Score: 21.25

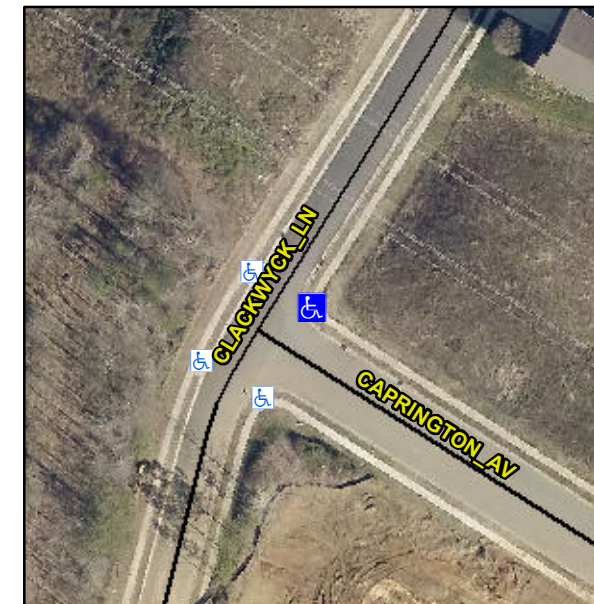
Not Found, R304.5.1, R304.5.3

Compliance	Description	Data	Compliance	Description	Data
N/A	Ramp Length (in)	48.0	Yes	Ramp Slope (%)	5.1
No	Ramp Width (in)	39.0	No	Ramp XSlope (%)	6.2
N/A	Flare Type LT	N/A	N/A	Flare Type RT	N/A
N/A	Flare Slope LT (%)	N/A	N/A	Flare Slope RT (%)	N/A
N/A	Flare Traversable LT?	N/A	N/A	Flare Traversable RT?	N/A
N/A	Landing Length (in)	N/A	N/A	DWS Provided?	N/A
N/A	Landing Width (in)	N/A	N/A	DWS Contrast?	N/A
N/A	Landing Slope (%)	N/A	N/A	DWS Length (in)	N/A
N/A	Landing X Slope (%)	N/A	N/A	DWS Full Width?	N/A
N/A	Landing Curb? (Y/N)	N/A	N/A	DWS Offset (in)	N/A
N/A	Shared Landing?	N/A			
N/A	Gutter Ponding?	N/A	N/A	Gutter Slope (%)	N/A
N/A	Gutter Lip Ht (in)	N/A	N/A	Gutter X Slope (%)	N/A
N/A	Painted X Walk1?	No	N/A	Painted X Walk2?	No
	X Walk 1 Direction	To NW		X Walk 2 Direction	To SW
N/A	X Walk 1 Width (in)	N/A	N/A	X Walk 2 Width (in)	N/A
	X Walk 1 Slope (%)	1.3		X Walk 2 Slope (%)	3.5
	X Walk 1 X Slope (%)	8.3		X Walk 2 X Slope (%)	6.5

N/A	Ramp inside XWalk1?	N/A	N/A	Ramp inside XWalk2?	N/A
	Road Slope (%)	4.0	N/A	Clear Space?	N/A
	Road X Slope (%)	3.8	N/A	Clear Space to XWalk (in)	N/A
N/A	Any Obstructions?	N/A	N/A	Storm Grate/Utility Hazard?	N/A
	Obstruction Type			Storm Grate/Utility Type	
		N/A			N/A
			Yes	Surface Condition? (G/P)	Good

Remove & Replace Curb Ramp With Two New Directional Ramps or Equivalent.
