Access Compliance Report Public Rights-of-Way (Curb Ramps)

Intersection ID: 26112Main Street: COLONIAL_HEIGHTS_DRCross Street: ELM_LNLocation:NWADA ID: 240DE674A3BBRamp Type: ParaInitial Pass/Fail: FailOverall Compliance: NoSeverity Score: 31.25

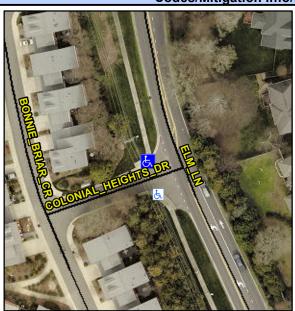
Field Measurements/Component Compliance							
Comp	liance Description	Data	Comp	liance Description	Data		
N/A	Ramp Length LT (in)	63.0	N/A	Ramp Length RT (in)	47.0		
No	Ramp Width LT (in)	34.0	No	Ramp Width RT (in)	33.0		
No	Ramp Slope LT (%)	9.2	Yes	Ramp Slope RT (%)	3.1		
No	Ramp XSlope LT (%)	2.3	Yes	Ramp XSlope RT (%)	0.4		
N/A	Landing Length (in)	N/A	N/A	DWS Provided?	N/A		
N/A	Landing Width (in)	N/A	N/A	DWS Contrast?	N/A		
N/A	Landing Slope (%)	N/A	N/A	DWS Length (in)	N/A		
N/A	Landing X Slope (%)	N/A	N/A	DWS Full Width?	N/A		
N/A	Landing Curb? (Y/N)	N/A	N/A	DWS Offset (in)	N/A		
N/A	Shared Landing?	N/A					
N/A	Gutter Ponding?	N/A	N/A	Gutter Slope (%)	N/A		
N/A	Gutter Lip Ht (in)	N/A	N/A	Gutter X Slope (%)	N/A		
N/A	Painted X Walk1?	No	N/A	Painted X Walk2?	N/A		
	X Walk 1 Direction	To S		X Walk 2 Direction	N/A		
N/A	X Walk 1 Width (in)	N/A	N/A	X Walk 2 Width (in)	N/A		
	X Walk 1 Slope (%)	0.7		X Walk 2 Slope (%)	N/A

X Walk 1 X Slope (%)	2.9		X Walk 2 X Slope (%)	N/A		
N/A	Ramp inside XWalk1?	N/A	N/A	Ramp inside XWalk2?	N/A		
	Road Slope (%)	N/A	N/A	Clear Space?	N/A		
	Road X Slope (%)	N/A	N/A	Clear Space to XWalk (in)	N/A		
N/A	Any Obstructions?	N/A	N/A	Storm Grate/Utility Hazard?	N/A		
	Obstruction Type			Storm Grate/Utility Type			
		N/A			N/A		
			Yes	Surface Condition? (G/P)	Good		
			N/A	Curb Slope (%)	17.2		
1

Possible Solutions:	Co
Remove & Replace Entire Ramp.	N/
•	No
	No
	No
	N/
	N/
Surveyor Notes:	N/
RT RP < 5%	N/
	N/
	N/
	N/
PROW/ADA:	N/
R304.5.1, R304.3.2, R304.5.3	N/
	N/

Total Cost: \$ 1600.00
