Access Compliance Report

Public Rights-of-Way (Curb Ramps)

Intersection ID: 9734	Main Street: FREEDOM_DR	Cross Street: S_I-85_HY	Location: NW
ADA ID: 241A8BD57B88	Ramp Type: Perp	Initial Pass/Fail: Fail	Overall Compliance: No Severity Score: 21.25

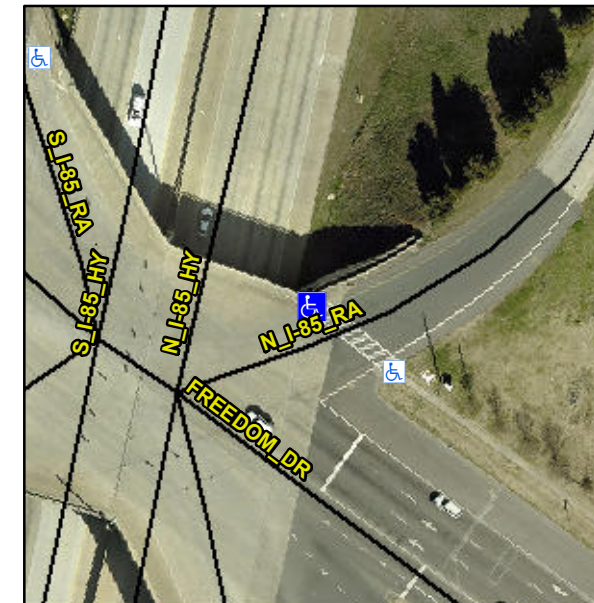
Compliance	Description	Data	Compliance	Description	Data
N/A	Ramp Length (in)	86.0	No	Ramp Slope (%)	9.0
No	Ramp Width (in)	46.0	Yes	Ramp XSlope (%)	1.2
N/A	Flare Type LT	N/A	N/A	Flare Type RT	N/A
N/A	Flare Slope LT (%)	N/A	N/A	Flare Slope RT (%)	N/A
N/A	Flare Traversable LT?	N/A	N/A	Flare Traversable RT?	N/A
N/A	Landing Length (in)	N/A	N/A	DWS Provided?	N/A
N/A	Landing Width (in)	N/A	N/A	DWS Contrast?	N/A
N/A	Landing Slope (%)	N/A	N/A	DWS Length (in)	N/A
N/A	Landing X Slope (%)	N/A	N/A	DWS Full Width?	N/A
N/A	Landing Curb? (Y/N)	N/A	N/A	DWS Offset (in)	N/A
N/A	Shared Landing?	N/A			
N/A	Gutter Ponding?	N/A	N/A	Gutter Slope (%)	N/A
N/A	Gutter Lip Ht (in)	N/A	N/A	Gutter X Slope (%)	N/A
N/A	Painted X Walk1?	Yes	N/A	Painted X Walk2?	N/A
	X Walk 1 Direction	To SE		X Walk 2 Direction	N/A
N/A	X Walk 1 Width (in)	109.5	N/A	X Walk 2 Width (in)	N/A
	X Walk 1 Slope (%)	0.7		X Walk 2 Slope (%)	N/A
	X Walk 1 X Slope (%)	2.5		X Walk 2 X Slope (%)	N/A

N/A	Ramp inside XWalk1?	Yes	N/A	Ramp inside XWalk2?	N/A
	Road Slope (%)	N/A	N/A	Clear Space?	N/A
	Road X Slope (%)	N/A	N/A	Clear Space to XWalk (in)	N/A
N/A	Any Obstructions?	N/A	N/A	Storm Grate/Utility Hazard?	N/A
	Obstruction Type			Storm Grate/Utility Type	
		N/A			N/A
			Yes	Surface Condition? (G/P)	Good

Remove & Replace Entire Ramp.

R304.5.1, R304.2.2
