## **Access Compliance Report Public Rights-of-Way** (Curb Ramps)

Intersection ID: 13474 Main Street: OLD\_STEELE\_CREEK\_RD **Cross Street: MARENE DR** Location: NW ADA ID: 2421FAB89A28 Ramp Type: ParaDiag Initial Pass/Fail: Fail **Overall Compliance: No Severity Score:** 22.5

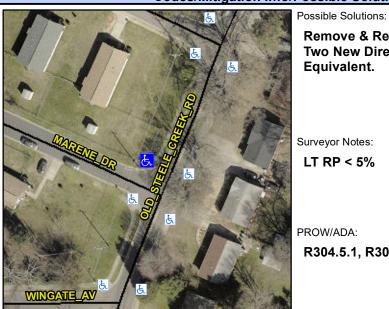
LT RP < 5%

Compliance Description		Data	Comp	oliance Description	Data
N/A	Ramp Length LT (in)	109.0	N/A	Ramp Length RT (in)	106.0
Yes	Ramp Width LT (in)	52.0	No	Ramp Width RT (in)	45.0
Yes	Ramp Slope LT (%)	0.1	No	Ramp Slope RT (%)	11.5
No	Ramp XSlope LT (%)	3.1	No	Ramp XSlope RT (%)	3.4
N/A	Landing Length (in)	N/A	N/A	DWS Provided?	N/A
N/A	Landing Width (in)	N/A	N/A	DWS Contrast?	N/A
N/A	Landing Slope (%)	N/A	N/A	DWS Length (in)	N/A
N/A	Landing X Slope (%)	N/A	N/A	DWS Full Width?	N/A
N/A	Landing Curb? (Y/N)	N/A	N/A	DWS Offset (in)	N/A
N/A	Shared Landing?	N/A			
N/A	Gutter Ponding?	N/A	N/A	Gutter Slope (%)	N/A
N/A	Gutter Lip Ht (in)	N/A	N/A	Gutter X Slope (%)	N/A
N/A	Painted X Walk1?	No	N/A	Painted X Walk2?	No
	X Walk 1 Direction	To S		X Walk 2 Direction	To E
N/A	X Walk 1 Width (in)	N/A	N/A	X Walk 2 Width (in)	N/A
	X Walk 1 Slope (%)	1.3		X Walk 2 Slope (%)	5.2
	X Walk 1 X Slope (%)	4.3		X Walk 2 X Slope (%)	2.1
N/A	Ramp inside XWalk1?	N/A	N/A	Ramp inside XWalk2?	N/A

Road Slope (%)	5.8	N/A	Clear Space?	N/A
	Road X Slope (%)	2.4	N/A	Clear Space to XWalk (in)	N/A
N/A	Any Obstructions?	N/A	N/A	Storm Grate/Utility Hazard?	N/A
	Obstruction Type			Storm Grate/Utility Type	
		N/A			N/A
			Yes	Surface Condition? (G/P)	Good
			N/A	Curb Slope (%)	14.8
	Marie Control of the

Street 1 Name Stop Condition-Stree Street 2 Name Stop Condition-Stree Remove & Replace Curb Ramp With Two New Directional Ramps or Equivalent.

R304.5.1, R304.5.3, R304.3.2

Total Cost: 3200.00
