# Access Compliance Report

## Public Rights-of-Way

### (Curb Ramps)

Intersection ID: 45281	Main Street: CIERA_NICHOLE_CT	Cross Street: LAKEHILL_RD	Location:	E
ADA ID: 242F1CF55164	Ramp Type: PerpDiag	Initial Pass/Fail: Fail	Overall Compliance: No	Severity Score: 30
Codes/Mitigation Info/Possible Solution		Field Measurements/Component Compliance

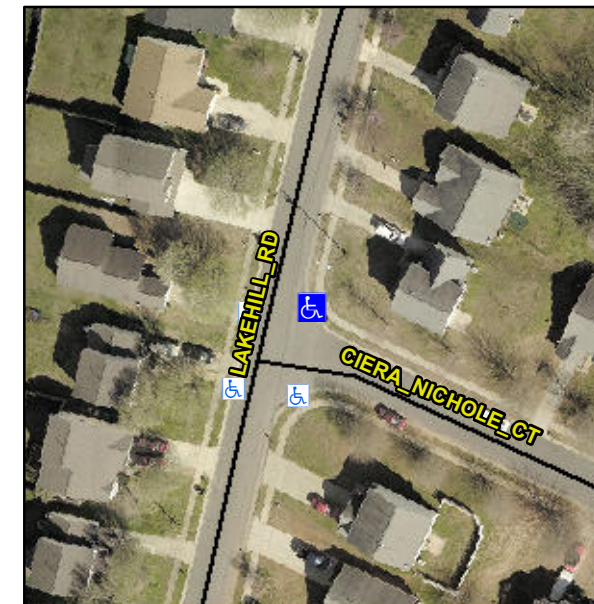
**R304.5.1, R304.5.3**

Compliance	Description	Data	Compliance	Description	Data
N/A	Ramp Length (in)	48.0	Yes	Ramp Slope (%)	6.7
No	Ramp Width (in)	35.5	No	Ramp XSlope (%)	5.1
N/A	Flare Type LT	N/A	N/A	Flare Type RT	N/A
N/A	Flare Slope LT (%)	N/A	N/A	Flare Slope RT (%)	N/A
N/A	Flare Traversable LT?	N/A	N/A	Flare Traversable RT?	N/A
N/A	Landing Length (in)	N/A	N/A	DWS Provided?	N/A
N/A	Landing Width (in)	N/A	N/A	DWS Contrast?	N/A
N/A	Landing Slope (%)	N/A	N/A	DWS Length (in)	N/A
N/A	Landing X Slope (%)	N/A	N/A	DWS Full Width?	N/A
N/A	Landing Curb? (Y/N)	N/A	N/A	DWS Offset (in)	N/A
N/A	Shared Landing?	N/A			
N/A	Gutter Ponding?	N/A	N/A	Gutter Slope (%)	N/A
N/A	Gutter Lip Ht (in)	N/A	N/A	Gutter X Slope (%)	N/A
N/A	Painted X Walk1?	No	N/A	Painted X Walk2?	No
	X Walk 1 Direction	To NW		X Walk 2 Direction	To SW
N/A	X Walk 1 Width (in)	N/A	N/A	X Walk 2 Width (in)	N/A
	X Walk 1 Slope (%)	6.9		X Walk 2 Slope (%)	3.5
	X Walk 1 X Slope (%)	4.9		X Walk 2 X Slope (%)	6.0

N/A	Ramp inside XWalk1?	N/A	N/A	Ramp inside XWalk2?	N/A
	Road Slope (%)	2.6	N/A	Clear Space?	N/A
	Road X Slope (%)	6.7	N/A	Clear Space to XWalk (in)	N/A
N/A	Any Obstructions?	N/A	N/A	Storm Grate/Utility Hazard?	N/A
	Obstruction Type			Storm Grate/Utility Type	
		N/A			N/A
			Yes	Surface Condition? (G/P)	Good

**Remove & Replace Curb Ramp With Two New Directional Ramps or Equivalent.**

Total Cost: \$ 3200.00
