# Access Compliance Report

## Public Rights-of-Way

### (Curb Ramps)

Intersection ID: 10014519	Main Street: UNIVERSITY_POINTE_BV	Cross Street: N/A	Location: E
ADA ID: 2433D72B3FA3	Ramp Type: PerpDiag	Initial Pass/Fail: Fail	Overall Compliance: No
Severity Score: 8.75			
Codes/Mitigation Info/Possible Solution		Field Measurements/Component Compliance

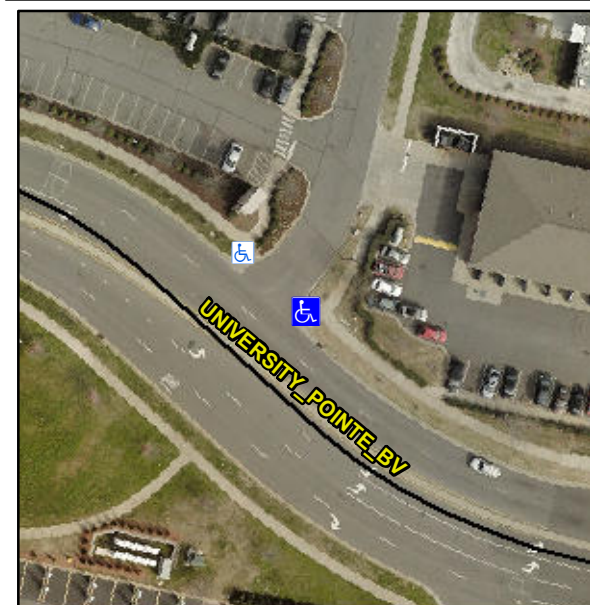
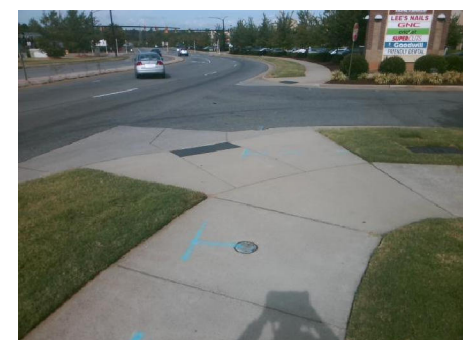
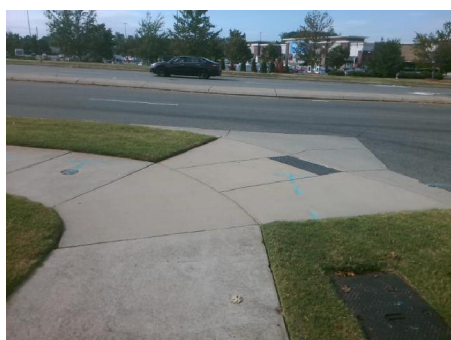
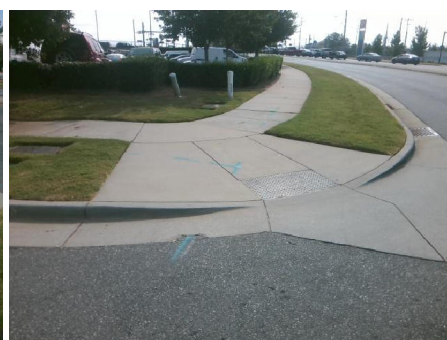
**Not Found, R304.5.1**

Compliance	Description	Data	Compliance	Description	Data
N/A	Ramp Length (in)	99.0	Yes	Ramp Slope (%)	7.2
No	Ramp Width (in)	44.0	Yes	Ramp XSlope (%)	0.2
N/A	Flare Type LT	N/A	N/A	Flare Type RT	N/A
N/A	Flare Slope LT (%)	N/A	N/A	Flare Slope RT (%)	N/A
N/A	Flare Traversable LT?	N/A	N/A	Flare Traversable RT?	N/A
N/A	Landing Length (in)	N/A	N/A	DWS Provided?	N/A
N/A	Landing Width (in)	N/A	N/A	DWS Contrast?	N/A
N/A	Landing Slope (%)	N/A	N/A	DWS Length (in)	N/A
N/A	Landing X Slope (%)	N/A	N/A	DWS Full Width?	N/A
N/A	Landing Curb? (Y/N)	N/A	N/A	DWS Offset (in)	N/A
N/A	Shared Landing?	N/A			
N/A	Gutter Ponding?	N/A	N/A	Gutter Slope (%)	N/A
N/A	Gutter Lip Ht (in)	N/A	N/A	Gutter X Slope (%)	N/A
N/A	Painted X Walk1?	No	N/A	Painted X Walk2?	No
	X Walk 1 Direction	To NW		X Walk 2 Direction	To SW
N/A	X Walk 1 Width (in)	N/A	N/A	X Walk 2 Width (in)	N/A
	X Walk 1 Slope (%)	3.4		X Walk 2 Slope (%)	0.5
	X Walk 1 X Slope (%)	3.5		X Walk 2 X Slope (%)	2.8

N/A	Ramp inside XWalk1?	N/A	N/A	Ramp inside XWalk2?	N/A
	Road Slope (%)	1.0	N/A	Clear Space?	N/A
	Road X Slope (%)	3.3	N/A	Clear Space to XWalk (in)	N/A
N/A	Any Obstructions?	N/A	N/A	Storm Grate/Utility Hazard?	N/A
	Obstruction Type			Storm Grate/Utility Type	
		N/A			N/A
			Yes	Surface Condition? (G/P)	Good

Possible Solutions:

**Remove & Replace Curb Ramp With Two New Directional Ramps or Equivalent.**
