# Access Compliance Report

## Public Rights-of-Way

### (Curb Ramps)

Intersection ID: 30238	Main Street: BLUE_TOPAZ_CT	Cross Street: SILVER_ORE_LN	Location: SW
ADA ID: 243E38621858	Ramp Type: PerpDiag	Initial Pass/Fail: Fail	Overall Compliance: No
Severity Score: 33.75			
Codes/Mitigation Info/Possible Solution		Field Measurements/Component Compliance

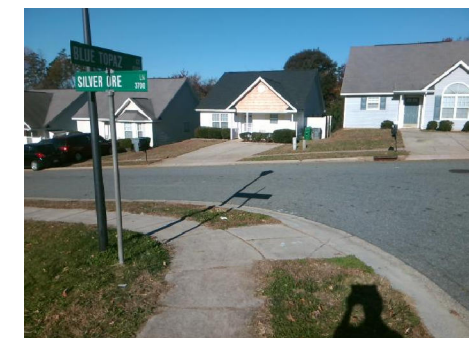
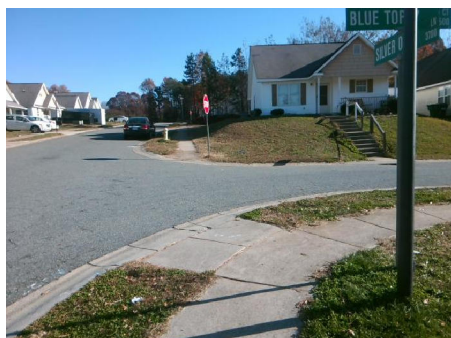
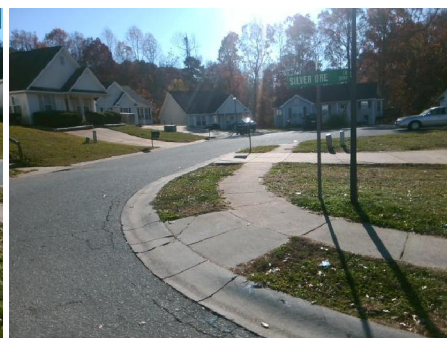
**Not Found, R304.5.1, R304.5.3**

Compliance	Description	Data	Compliance	Description	Data
N/A	Ramp Length (in)	46.0	Yes	Ramp Slope (%)	6.3
No	Ramp Width (in)	44.0	No	Ramp XSlope (%)	9.6
N/A	Flare Type LT	N/A	N/A	Flare Type RT	N/A
N/A	Flare Slope LT (%)	N/A	N/A	Flare Slope RT (%)	N/A
N/A	Flare Traversable LT?	N/A	N/A	Flare Traversable RT?	N/A
N/A	Landing Length (in)	N/A	N/A	DWS Provided?	N/A
N/A	Landing Width (in)	N/A	N/A	DWS Contrast?	N/A
N/A	Landing Slope (%)	N/A	N/A	DWS Length (in)	N/A
N/A	Landing X Slope (%)	N/A	N/A	DWS Full Width?	N/A
N/A	Landing Curb? (Y/N)	N/A	N/A	DWS Offset (in)	N/A
N/A	Shared Landing?	N/A			
N/A	Gutter Ponding?	N/A	N/A	Gutter Slope (%)	N/A
N/A	Gutter Lip Ht (in)	N/A	N/A	Gutter X Slope (%)	N/A
N/A	Painted X Walk1?	No	N/A	Painted X Walk2?	No
	X Walk 1 Direction	To NE		X Walk 2 Direction	To NW
N/A	X Walk 1 Width (in)	N/A	N/A	X Walk 2 Width (in)	N/A
	X Walk 1 Slope (%)	6.0		X Walk 2 Slope (%)	4.5
	X Walk 1 X Slope (%)	4.9		X Walk 2 X Slope (%)	8.6

N/A	Ramp inside XWalk1?	N/A	N/A	Ramp inside XWalk2?	N/A
	Road Slope (%)	4.6	N/A	Clear Space?	N/A
	Road X Slope (%)	6.1	N/A	Clear Space to XWalk (in)	N/A
N/A	Any Obstructions?	N/A	N/A	Storm Grate/Utility Hazard?	N/A
	Obstruction Type			Storm Grate/Utility Type	
		N/A			N/A
		Yes		Surface Condition? (G/P)	Good

**Remove & Replace Curb Ramp With Two New Directional Ramps or Equivalent.**
