## Access Compliance Report Public Rights-of-Way (Curb Ramps)

Intersection ID: 12018 Main Street: S\_GRAHAM\_ST Cross Street: W\_3RD-4TH\_CONNECTOR\_ST Location: W

ADA ID: 243E39449C5C Ramp Type: PerpDiag Initial Pass/Fail: Fail Overall Compliance: No Severity Score: 8.75

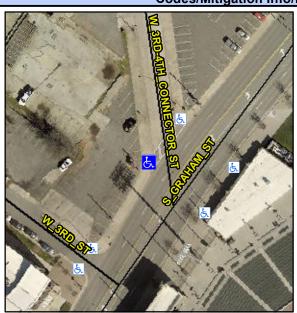
Not Found, R304.5.1

| Field Measurements/Component Compliance | | | | | | |
|---|---|---|---|---|---|---|
| | No | Ramp Width (in) | 42.0 | Yes | Ramp XSlope (%) | 0.4 |

Remove & Replace Curb Ramp With Two New Directional Ramps or Equivalent.
