# Access Compliance Report

## Public Rights-of-Way

### (Curb Ramps)

Intersection ID: 30490	Main Street: BRAMWYCK_DR	Cross Street: QUAIL_PARK_DR	Location: SE
ADA ID: 245CE9889384	Ramp Type: PerpDiag	Initial Pass/Fail: Fail	Overall Compliance: No
Severity Score: 21.25			
Codes/Mitigation Info/Possible Solution		Field Measurements/Component Compliance

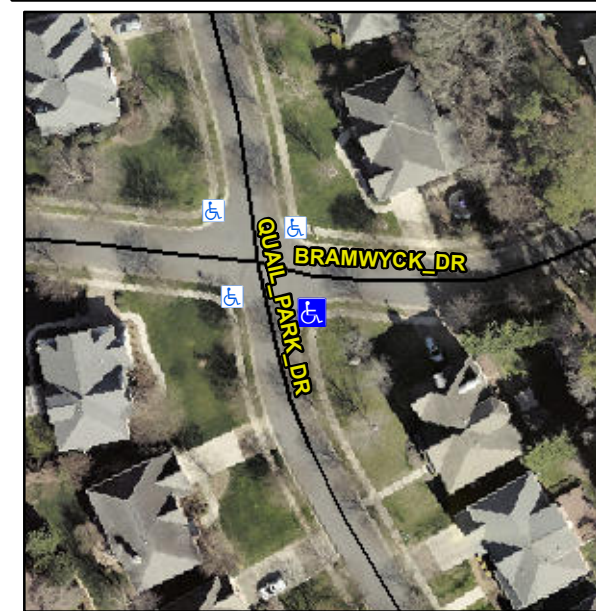
**Not Found, R304.5.1, R304.5.3**

Compliance	Description	Data	Compliance	Description	Data
N/A	Ramp Length (in)	47.5	Yes	Ramp Slope (%)	7.1
No	Ramp Width (in)	43.5	No	Ramp XSlope (%)	5.7
N/A	Flare Type LT	N/A	N/A	Flare Type RT	N/A
N/A	Flare Slope LT (%)	N/A	N/A	Flare Slope RT (%)	N/A
N/A	Flare Traversable LT?	N/A	N/A	Flare Traversable RT?	N/A
N/A	Landing Length (in)	N/A	N/A	DWS Provided?	N/A
N/A	Landing Width (in)	N/A	N/A	DWS Contrast?	N/A
N/A	Landing Slope (%)	N/A	N/A	DWS Length (in)	N/A
N/A	Landing X Slope (%)	N/A	N/A	DWS Full Width?	N/A
N/A	Landing Curb? (Y/N)	N/A	N/A	DWS Offset (in)	N/A
N/A	Shared Landing?	N/A			
N/A	Gutter Ponding?	N/A	N/A	Gutter Slope (%)	N/A
N/A	Gutter Lip Ht (in)	N/A	N/A	Gutter X Slope (%)	N/A
N/A	Painted X Walk1?	No	N/A	Painted X Walk2?	No
	X Walk 1 Direction	To N		X Walk 2 Direction	To NW
N/A	X Walk 1 Width (in)	N/A	N/A	X Walk 2 Width (in)	N/A
	X Walk 1 Slope (%)	0.2		X Walk 2 Slope (%)	2.6
	X Walk 1 X Slope (%)	4.4		X Walk 2 X Slope (%)	4.2

N/A	Ramp inside XWalk1?	N/A	N/A	Ramp inside XWalk2?	N/A
	Road Slope (%)	4.0	N/A	Clear Space?	N/A
	Road X Slope (%)	0.1	N/A	Clear Space to XWalk (in)	N/A
N/A	Any Obstructions?	N/A	N/A	Storm Grate/Utility Hazard?	N/A
	Obstruction Type			Storm Grate/Utility Type	
		N/A			N/A
		Yes		Surface Condition? (G/P)	Good

**Remove & Replace Curb Ramp With Two New Directional Ramps or Equivalent.**

Total Cost: \$ 3200.00
