# Access Compliance Report

## Public Rights-of-Way

### (Curb Ramps)

Intersection ID: 52363	Main Street: DUNAVANT_ST	Cross Street: IRONSIDE_AV	Location: S
ADA ID: 246799BC2B0F	Ramp Type: Directional1	Initial Pass/Fail: Fail	Overall Compliance: No
Codes/Mitigation Info/Possible Solution		Field Measurements/Component Compliance	
Severity Score: 13.75

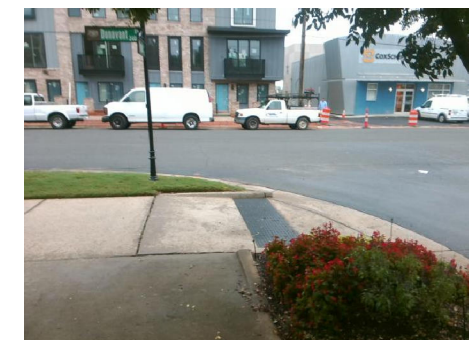
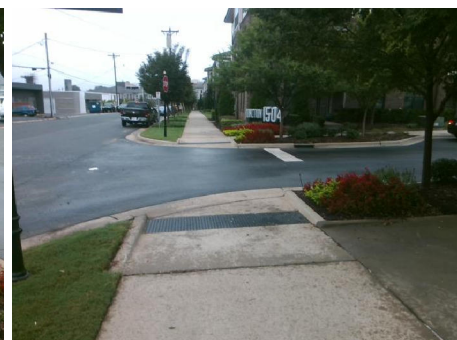
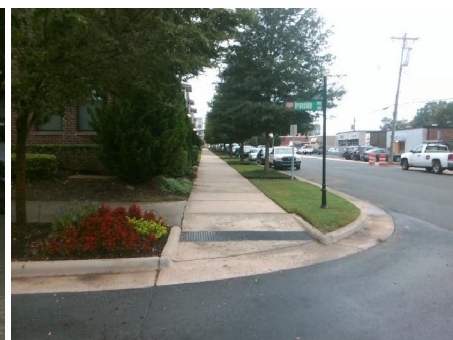
N/A	Shared Landing?	N/A	N/A DWS Offset RT (in) N/A
		N/A	Gutter Ponding?	0.0	N/A Gutter Slope (%) N/A
		N/A	Gutter Lip Ht (in)	0.0	N/A Gutter X Slope (%) N/A
		N/A	Painted X Walk1?	No	Road Slope (%) 2.3
			X Walk 1 Direction	To NE	Road X Slope (%) 1.0
			X Walk 1 Width (in)	N/A	Clear Space? N/A
			X Walk 1 Slope (%)	2.3	N/A Clear Space to XWalk (in) N/A
			X Walk 1 X Slope (%)	1.0	N/A Storm Grate/Utility Hazard? N/A
		N/A	Ramp inside XWalk1?	N/A	Storm Grate/Utility Type
		N/A	Any Obstructions?	N/A	N/A
			Obstruction Type		Yes Surface Condition? (G/P) Good
				N/A	N/A Curb Slope (%) 8.7

Possible Solutions:				
	Remove & Replace Entire Ramp.				
	Surveyor Notes:				
	N/A				
	PROW/ADA:				
	R304.2.2, R304.5.3				
	Street 1 Name	IRONSIDE AV			
	Stop Condition-Street 1	StopSign			
	Street 2 Name	N/A			
	Stop Condition-Street 2	N/A			
Total Cost:		\$	1600.00		
		Compliance	Description	Data	Compliance Description Data
		N/A	Ramp Length (in)	78.0	N/A Grade Break? N/A
		Yes	Ramp Width (in)	96.0	N/A Grade Break Slope (%) 0.0
		No	Ramp Slope (%)	10.8	N/A Grade Break XSlope (%) 0.0
		No	Ramp XSlope (%)	3.9	
		N/A	Flare Type LT	N/A	N/A Flare Type RT N/A
		N/A	Flare Slope LT (%)	N/A	N/A Flare Slope RT (%) 0.0
		N/A	Flare Traversable LT?	N/A	N/A Flare Traversable RT? N/A
		N/A	Landing Length (in)	0.0	N/A DWS Provided? N/A
		N/A	Landing Width (in)	0.0	N/A DWS Contrast? N/A
		N/A	Landing Slope (%)	0.0	N/A DWS Length (in) N/A
		N/A	Landing X Slope (%)	0.0	N/A DWS Full Width? N/A
		N/A	Landing Curb? (Y/N)	N/A	N/A DWS Offset LT (in) N/A
