Access Compliance Report Public Rights-of-Way (Curb Ramps)

Main Street: EAGLEWIND DR Intersection ID: 18040 **Cross Street: PINEY GROVE RD** Location: SW **Overall Compliance: No Severity Score:** 25 ADA ID: 24687873C501 Ramp Type: BlendTrans2 Initial Pass/Fail: Fail

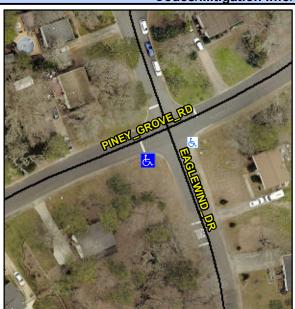
Total Cost: 3200.00 Compliance Description Data Compliance Description Data Yes N/A Ramp Length (in) 46.0 BlendTrans Slope (%) 0.4 No Yes Ramp Width (in) 48.0 BlendTrans XSlope (%) 10.2 N/A Flare Type RT N/A Flare Type LT N/A N/A N/A N/A N/A Flare Slope RT (%) N/A Flare Slope LT (%) N/A Flare Traversable LT? N/A N/A Flare Traversable RT? N/A N/A N/A N/A **DWS Provided?** N/A Landing Length (in) N/A Landing Width (in) N/A N/A **DWS Contrast?** N/A N/A N/A N/A Landing Slope (%) DWS Length (in) N/A N/A Landing X Slope (%) N/A N/A DWS Full Width? N/A N/A Landing Curb? (Y/N) N/A N/A DWS Offset (in) N/A N/A N/A Shared Landing? N/A **Gutter Ponding?** N/A N/A Gutter Slope (%) N/A N/A Gutter Lip Ht (in) N/A N/A Gutter X Slope (%) N/A N/A Painted X Walk1? No N/A Painted X Walk2? No X Walk 1 Direction To NE X Walk 2 Direction To N N/A X Walk 1 Width (in) X Walk 2 Width (in) N/A X Walk 1 Slope (%) 9.6 X Walk 2 Slope (%) 1.1 X Walk 1 X Slope (%) 1.2 X Walk 2 X Slope (%) 8.9 N/A N/A Ramp inside XWalk2? N/A N/A Ramp inside XWalk1? Road Slope (%) 7.7 Clear Space? N/A Road X Slope (%) 7.2 N/A N/A Clear Space to XWalk (in) N/A N/A N/A Any Obstructions? Storm Grate/Utility Hazard? N/A Obstruction Type Storm Grate/Utility Type N/A N/A Yes Surface Condition? (G/P) Good No 22.9

Curb Slope (%)

EAGLEWIND DR StopSign **PINEY GROVE RD** StopSign Possible Solutions: Remove & Replace Curb Ramp With Two New Directional Ramps or Equivalent. Surveyor Notes: N/A PROW/ADA: Not Found, R304.5.3
