## Access Compliance Report Public Rights-of-Way (Curb Ramps)

Intersection ID: 27452 Main Street: BALLANTYNE\_COMMONS\_PY Cross Street: BALLANTYNE\_CORPORATE\_PL Location: SW

ADA ID: 248A9CB8765E Ramp Type: Perp Initial Pass/Fail: Fail Overall Compliance: No Severity Score: 25

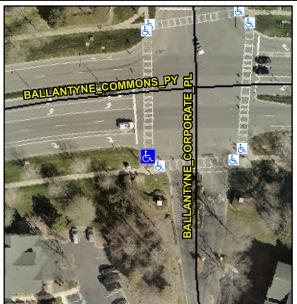
D/Possible Solution	Field Measurements/Component Compilance						
Possible Solutions:	Comp	liance Description	Data	Comp	liance	Description	Data
Remove & Replace Entire Ramp.	N/A	Ramp Length (in)	96.0	Yes	Ramp	Slope (%)	5.7
	Yes	Ramp Width (in)	48.0	No	Ramp	XSlope (%)	8.0
	N/A	Flare Type LT	N/A	N/A	Flare	Гуре RT	N/A
<u>#</u>	N/A	Flare Slope LT (%)	N/A	N/A	Flare	Slope RT (%)	N/A
	N/A	Flare Traversable LT?	N/A	N/A	Flare	Traversable RT?	N/A
	N/A	Landing Length (in)	N/A	N/A	DWS I	Provided?	N/A
Surveyor Notes:	N/A	Landing Width (in)	N/A	N/A	DWS (	Contrast?	N/A
N/A	N/A	Landing Slope (%)	N/A	N/A	DWS I	Length (in)	N/A
	N/A	Landing X Slope (%)	N/A	N/A	DWS I	Full Width?	N/A
	N/A	Landing Curb? (Y/N)	N/A	N/A	DWS (	Offset (in)	N/A
	N/A	Shared Landing?	N/A				
PROW/ADA:	N/A	Gutter Ponding?	N/A	N/A	Gutter	Slope (%)	N/A
Not Found, R304.5.3	N/A	Gutter Lip Ht (in)	N/A	N/A	Gutter	X Slope (%)	N/A
· ·	N/A	Painted X Walk1?	Yes	N/A	Painte	d X Walk2?	N/A

X Walk 1 Direction	To NE		X Wall	c 2 Direction	N/A
	N/A	X Walk 1 Width (in)	111.0	N/A	X Wall	c 2 Width (in)	N/A
		X Walk 1 Slope (%)	1.4		X Wall	< 2 Slope (%)	N/A
		X Walk 1 X Slope (%)	6.7		X Wall	< 2 X Slope (%)	N/A
	N/A	Ramp inside XWalk1?	Yes	N/A	Ramp	inside XWalk2?	N/A
		Road Slope (%)	N/A	N/A	Clear	Space?	N/A
		Road X Slope (%)	N/A	N/A	Clear	Space to XWalk (in)	N/A
	N/A	Any Obstructions?	N/A	N/A	Storm	Grate/Utility Hazard?	N/A
Total Cost: \$ 1850.00		Obstruction Type			Storm	Grate/Utility Type	
			N/A				N/A
