Access Compliance Report

Public Rights-of-Way

(Curb Ramps)

Intersection ID: 9612	Main Street: BELLEFONTE_DR	Cross Street: N_PINE_ST	Location: NE
ADA ID: 2492078D3D4E	Ramp Type: Perp	Initial Pass/Fail: Fail	Overall Compliance: No
Severity Score: 10			
Codes/Mitigation Info/Possible Solution		Field Measurements/Component Compliance

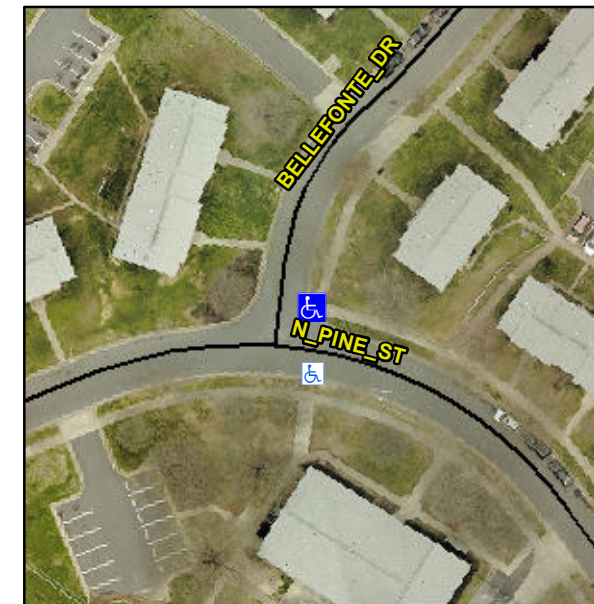
Not Found, R304.5.1, R304.5.3

Compliance	Description	Data	Compliance	Description	Data
N/A	Ramp Length (in)	67.5	Yes	Ramp Slope (%)	6.6
No	Ramp Width (in)	47.5	No	Ramp XSlope (%)	2.6
N/A	Flare Type LT	N/A	N/A	Flare Type RT	N/A
N/A	Flare Slope LT (%)	N/A	N/A	Flare Slope RT (%)	N/A
N/A	Flare Traversable LT?	N/A	N/A	Flare Traversable RT?	N/A
N/A	Landing Length (in)	N/A	N/A	DWS Provided?	N/A
N/A	Landing Width (in)	N/A	N/A	DWS Contrast?	N/A
N/A	Landing Slope (%)	N/A	N/A	DWS Length (in)	N/A
N/A	Landing X Slope (%)	N/A	N/A	DWS Full Width?	N/A
N/A	Landing Curb? (Y/N)	N/A	N/A	DWS Offset (in)	N/A
N/A	Shared Landing?	N/A			
N/A	Gutter Ponding?	N/A	N/A	Gutter Slope (%)	N/A
N/A	Gutter Lip Ht (in)	1.0	N/A	Gutter X Slope (%)	N/A
N/A	Painted X Walk1?	No	N/A	Painted X Walk2?	N/A
	X Walk 1 Direction	To S		X Walk 2 Direction	N/A
N/A	X Walk 1 Width (in)	N/A	N/A	X Walk 2 Width (in)	N/A
	X Walk 1 Slope (%)	1.0		X Walk 2 Slope (%)	N/A
	X Walk 1 X Slope (%)	1.7		X Walk 2 X Slope (%)	N/A

Possible Solutions:

Remove & Replace Entire Ramp.

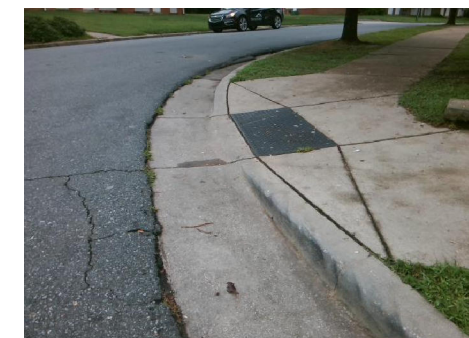
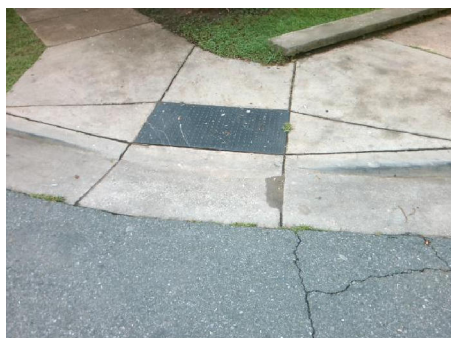
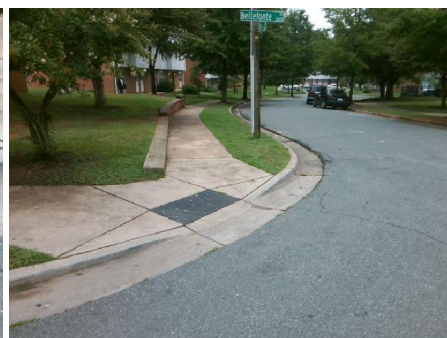
N/A	Ramp inside XWalk1?	N/A	N/A	Ramp inside XWalk2?	N/A
	Road Slope (%)	N/A	N/A	Clear Space?	N/A
	Road X Slope (%)	N/A	N/A	Clear Space to XWalk (in)	N/A
N/A	Any Obstructions?	N/A	N/A	Storm Grate/Utility Hazard?	N/A
	Obstruction Type			Storm Grate/Utility Type	
		N/A			N/A
		Yes		Surface Condition? (G/P)	Good
