Access Compliance Report Public Rights-of-Way (Curb Ramps)

Intersection ID: 23740 Main Street: PARK_RD Cross Street: SMITHFIELD_CHURCH_RD Location: SE

ADA ID: 2499D72F7175 Ramp Type: PerpDiag Initial Pass/Fail: Fail Overall Compliance: No Severity Score: 25

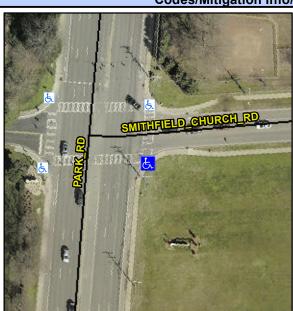
Compliance Description		Data		liance Description	Data
N/A	Ramp Length (in)	60.0	No	Ramp Slope (%)	9.9
Yes	Ramp Width (in)	48.0	No	Ramp XSlope (%)	5.6
N/A	Flare Type LT	N/A	N/A	Flare Type RT	N/A
N/A	Flare Slope LT (%)	N/A	N/A	Flare Slope RT (%)	N/A
N/A	Flare Traversable LT?	N/A	N/A	Flare Traversable RT?	N/A
N/A	Landing Length (in)	N/A	N/A	DWS Provided?	N/A
N/A	Landing Width (in)	N/A	N/A	DWS Contrast?	N/A
N/A	Landing Slope (%)	N/A	N/A	DWS Length (in)	N/A
N/A	Landing X Slope (%)	N/A	N/A	DWS Full Width?	N/A
N/A	Landing Curb? (Y/N)	N/A	N/A	DWS Offset (in)	N/A
N/A	Shared Landing?	N/A			
N/A	Gutter Ponding?	N/A	N/A	Gutter Slope (%)	N/A
N/A	Gutter Lip Ht (in)	N/A	N/A	Gutter X Slope (%)	N/A
N/A	Painted X Walk1?	Yes	N/A	Painted X Walk2?	Yes
	X Walk 1 Direction	To NE		X Walk 2 Direction	To NW
N/A	X Walk 1 Width (in)	109.0	N/A	X Walk 2 Width (in)	101.0
	X Walk 1 Slope (%)	1.5		X Walk 2 Slope (%)	5.4
	X Walk 1 X Slope (%)	6.7		X Walk 2 X Slope (%)	0.1

N/A	Ramp inside XWalk1?	Yes	N/A	Ramp inside XWalk2?	Yes
	Road Slope (%)	5.1	N/A	Clear Space?	N/A
	Road X Slope (%)	3.6	N/A	Clear Space to XWalk (in)	N/A
N/A	Any Obstructions?	N/A	N/A	Storm Grate/Utility Hazard?	N/A
	Obstruction Type			Storm Grate/Utility Type	
		N/A			N/A

Remove & Replace Curb Ramp With
Two New Directional Ramps or
Equivalent.

R304.2.2, R304.5.3
