Access Compliance Report Public Rights-of-Way (Curb Ramps)

Intersection ID: 3033 Main Street: DEARMON_RD Cross Street: BENFIELD_RD Location: W

ADA ID: 24BBCF223314 Ramp Type: Perp Initial Pass/Fail: Fail Overall Compliance: No Severity Score: 26.25

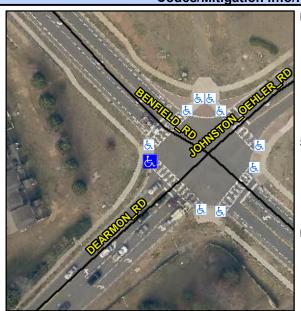
Field Measurements/Component Compliance						
	Compliance Description		Data	Compliance Description		Data
	N/A	Ramp Length (in)	97.0	No	Ramp Slope (%)	15.3
	Yes	Ramp Width (in)	85.0	No	Ramp XSlope (%)	2.3
	N/A	Flare Type LT	N/A	N/A	Flare Type RT	N/A
	N/A	Flare Slope LT (%)	N/A	N/A	Flare Slope RT (%)	N/A
	N/A	Flare Traversable LT?	N/A	N/A	Flare Traversable RT?	N/A
	N/A	Landing Length (in)	N/A	N/A	DWS Provided?	N/A
	N/A	Landing Width (in)	N/A	N/A	DWS Contrast?	N/A
	N/A	Landing Slope (%)	N/A	N/A	DWS Length (in)	N/A
	N/A	Landing X Slope (%)	N/A	N/A	DWS Full Width?	N/A
	N/A	Landing Curb? (Y/N)	N/A	N/A	DWS Offset (in)	N/A
	N/A	Shared Landing?	N/A			
	N/A	Gutter Ponding?	N/A	N/A	Gutter Slope (%)	N/A
	N/A	Gutter Lip Ht (in)	N/A	N/A	Gutter X Slope (%)	N/A
	N/A	Painted X Walk1?	Yes	N/A	Painted X Walk2?	N/A
		X Walk 1 Direction	To SE		X Walk 2 Direction	N/A
	N/A	X Walk 1 Width (in)	118.5	N/A	X Walk 2 Width (in)	N/A
		X Walk 1 Slope (%)	2.3		X Walk 2 Slope (%)	N/A

X Walk 1 X Slope (%)	0.7		X Walk 2 X Slope (%)	N/A
	N/A	Ramp inside XWalk1?	Yes	N/A	Ramp inside XWalk2?	N/A
		Road Slope (%)	N/A	N/A	Clear Space?	N/A
		Road X Slope (%)	N/A	N/A	Clear Space to XWalk (in)	N/A
	N/A	Any Obstructions?	N/A	N/A	Storm Grate/Utility Hazard?	N/A
		Obstruction Type			Storm Grate/Utility Type	
			N/A			N/A
				Yes	Surface Condition? (G/P)	Good

Remove & Replace Entire Ramp.

R304.2.2, R304.5.3
