Access Compliance Report

Public Rights-of-Way

(Curb Ramps)

Intersection ID: 20264	Main Street: DINGESS_RD	Cross Street: MEADHAVEN_DR	Location: E
ADA ID: 24C14F3EDF03	Ramp Type: PerpDiag	Initial Pass/Fail: Fail	Overall Compliance: No
		Severity Score: 22.5

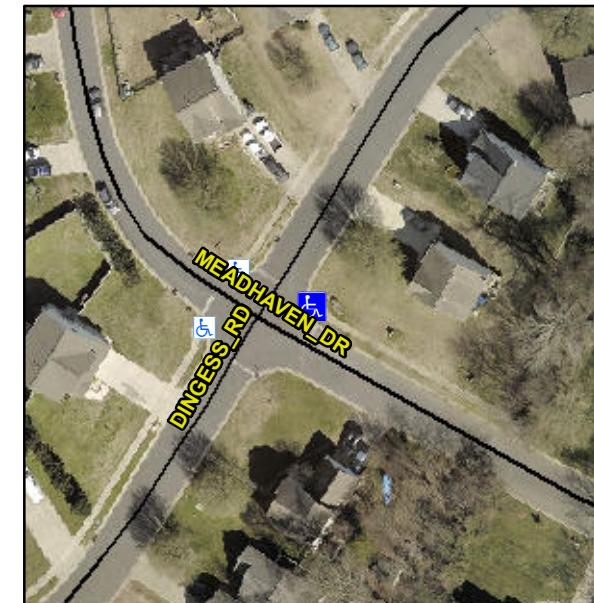
Compliance	Description	Data	Compliance	Description	Data
N/A	Ramp Length (in)	46.0	No	Ramp Slope (%)	8.8
No	Ramp Width (in)	38.0	No	Ramp XSlope (%)	3.1
N/A	Flare Type LT	N/A	N/A	Flare Type RT	N/A
N/A	Flare Slope LT (%)	N/A	N/A	Flare Slope RT (%)	N/A
N/A	Flare Traversable LT?	N/A	N/A	Flare Traversable RT?	N/A
N/A	Landing Length (in)	N/A	N/A	DWS Provided?	N/A
N/A	Landing Width (in)	N/A	N/A	DWS Contrast?	N/A
N/A	Landing Slope (%)	N/A	N/A	DWS Length (in)	N/A
N/A	Landing X Slope (%)	N/A	N/A	DWS Full Width?	N/A
N/A	Landing Curb? (Y/N)	N/A	N/A	DWS Offset (in)	N/A
N/A	Shared Landing?	N/A			
N/A	Gutter Ponding?	N/A	N/A	Gutter Slope (%)	N/A
N/A	Gutter Lip Ht (in)	N/A	N/A	Gutter X Slope (%)	N/A
N/A	Painted X Walk1?	No	N/A	Painted X Walk2?	No
	X Walk 1 Direction	To NW		X Walk 2 Direction	To SW
N/A	X Walk 1 Width (in)	N/A	N/A	X Walk 2 Width (in)	N/A
	X Walk 1 Slope (%)	3.5		X Walk 2 Slope (%)	1.5
	X Walk 1 X Slope (%)	0.8		X Walk 2 X Slope (%)	3.0

N/A	Ramp inside XWalk1?	N/A	N/A	Ramp inside XWalk2?	N/A
	Road Slope (%)	4.0	N/A	Clear Space?	N/A
	Road X Slope (%)	0.2	N/A	Clear Space to XWalk (in)	N/A
N/A	Any Obstructions?	N/A	N/A	Storm Grate/Utility Hazard?	N/A
	Obstruction Type			Storm Grate/Utility Type	
		N/A			N/A
			Yes	Surface Condition? (G/P)	Good

Possible Solutions:

Remove & Replace Curb Ramp With Two New Directional Ramps or Equivalent.

R304.5.1, R304.2.2, R304.5.3
