# Access Compliance Report

## Public Rights-of-Way

### (Curb Ramps)

| Intersection ID: 26425 | Main Street: BEVINGTON_PL | Cross Street: BIRKDALE_VALLEY_DR | Location: E |

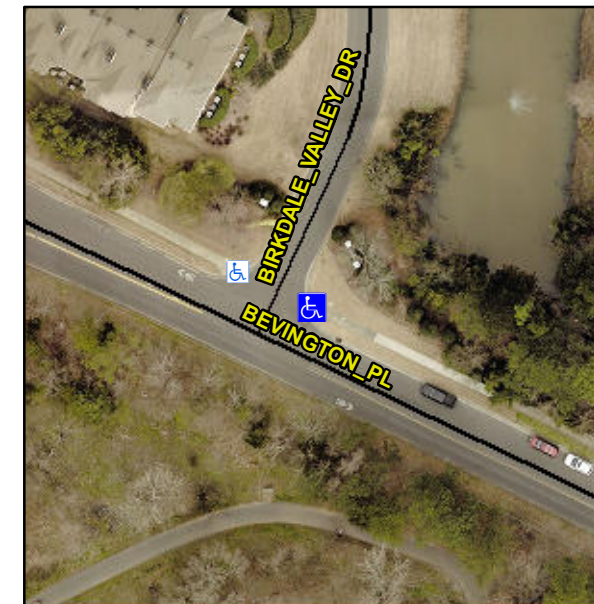
**Not Found, R304.5.3, R305.1.4, R305.2**

| Compliance | Description | Data | Compliance | Description | Data |
|---|---|---|---|---|---|
| Yes | Ramp Width (in) | 48.0 | No | BlendTrans XSlope (%) | 4.8 |
| N/A | Landing X Slope (%) | N/A | No | DWS Full Width? | No |
| Yes | Gutter Lip Ht (in) | 0.0 | No | Gutter X Slope (%) | 4.3 |

**Remove & Replace Curb Ramp With Two New Directional Ramps or Equivalent. Remove & Replace Gutter.**

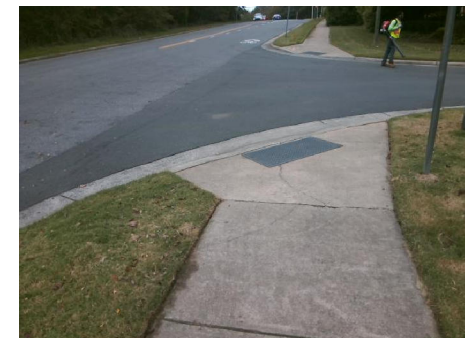
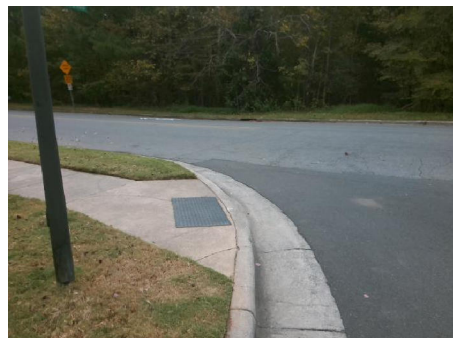
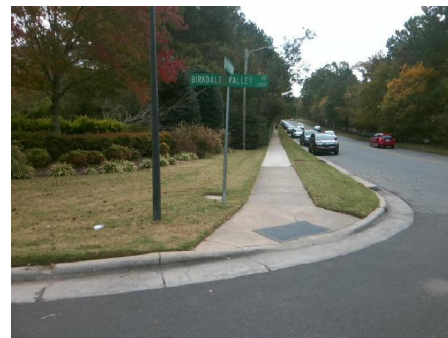
| ADA ID: 24C9A847DFF8 | Ramp Type: BlendTrans2 | Initial Pass/Fail: Pass | Overall Compliance: No |
| | | Severity Score: 2.75 | |

| Compliance | Description | Data | Compliance | Description | Data |
|---|---|---|---|---|---|
| | | | No | Curb Slope (%) | 10.5 |
