Access Compliance Report

Public Rights-of-Way

(Curb Ramps)

Intersection ID: 14272	Main Street: BROOKHILL_RD	Cross Street: VILLAGE_CT	Location: SW
ADA ID: 24E0D5B775EC	Ramp Type: PerpDiag	Initial Pass/Fail: Fail	Overall Compliance: No
Codes/Mitigation Info/Possible Solution		Field Measurements/Component Compliance	
Severity Score: 13.75

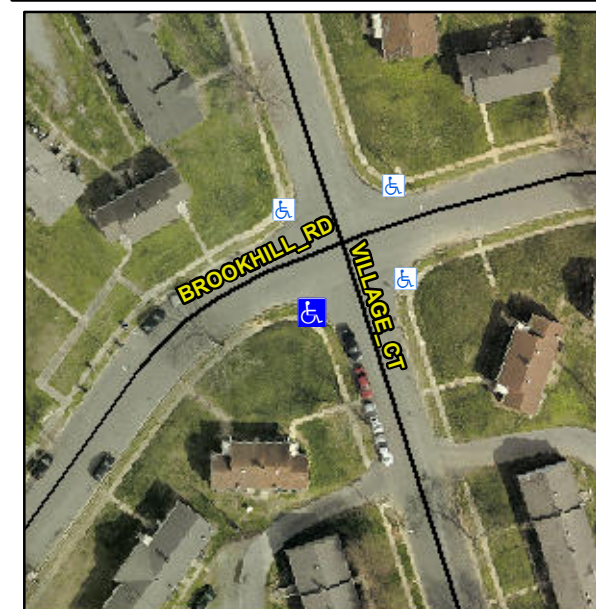
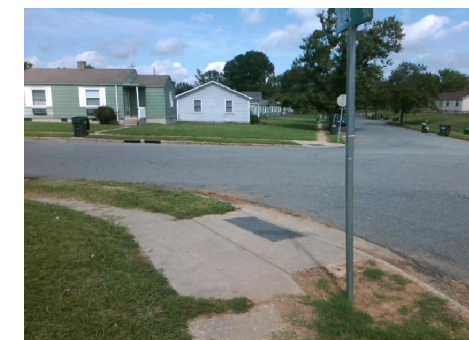
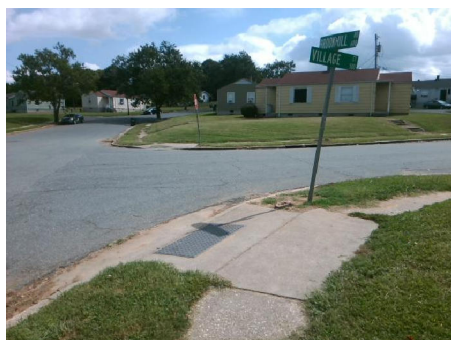
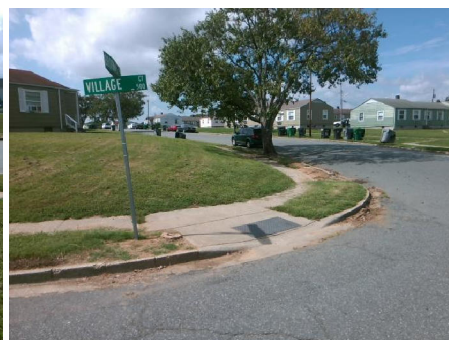
Not Found, R304.2.2, R304.5.3

Compliance	Description	Data	Compliance	Description	Data
N/A	Ramp Length (in)	43.0	No	Ramp Slope (%)	11.1
Yes	Ramp Width (in)	48.0	No	Ramp XSlope (%)	3.2
N/A	Flare Type LT	N/A	N/A	Flare Type RT	N/A
N/A	Flare Slope LT (%)	N/A	N/A	Flare Slope RT (%)	N/A
N/A	Flare Traversable LT?	N/A	N/A	Flare Traversable RT?	N/A
N/A	Landing Length (in)	N/A	N/A	DWS Provided?	N/A
N/A	Landing Width (in)	N/A	N/A	DWS Contrast?	N/A
N/A	Landing Slope (%)	N/A	N/A	DWS Length (in)	N/A
N/A	Landing X Slope (%)	N/A	N/A	DWS Full Width?	N/A
N/A	Landing Curb? (Y/N)	N/A	N/A	DWS Offset (in)	N/A
N/A	Shared Landing?	N/A			
N/A	Gutter Ponding?	N/A	N/A	Gutter Slope (%)	N/A
N/A	Gutter Lip Ht (in)	N/A	N/A	Gutter X Slope (%)	N/A
N/A	Painted X Walk1?	No	N/A	Painted X Walk2?	No
	X Walk 1 Direction	To E		X Walk 2 Direction	To N
N/A	X Walk 1 Width (in)	N/A	N/A	X Walk 2 Width (in)	N/A
	X Walk 1 Slope (%)	3.7		X Walk 2 Slope (%)	0.2
	X Walk 1 X Slope (%)	1.8		X Walk 2 X Slope (%)	2.6

N/A	Ramp inside XWalk1?	N/A	N/A	Ramp inside XWalk2?	N/A
	Road Slope (%)	0.2	N/A	Clear Space?	N/A
	Road X Slope (%)	0.7	N/A	Clear Space to XWalk (in)	N/A
N/A	Any Obstructions?	N/A	N/A	Storm Grate/Utility Hazard?	N/A
	Obstruction Type			Storm Grate/Utility Type	
		N/A			N/A
			Yes	Surface Condition? (G/P)	Good

Remove & Replace Curb Ramp With Two New Directional Ramps or Equivalent.
