# Access Compliance Report

## Public Rights-of-Way

### (Curb Ramps)

| Intersection ID: 9578 | Main Street: WOODWARD_AV | Cross Street: STATESVILLE_AV | Location: SW |

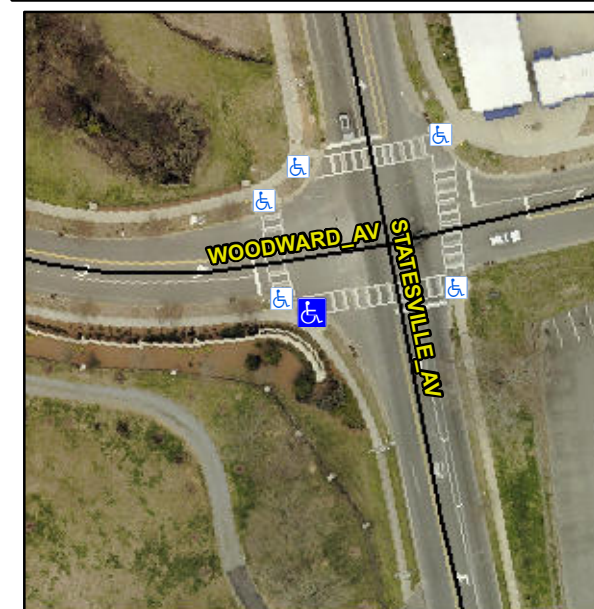
| ADA ID: 24E36823D8CC | Ramp Type: Perp | Initial Pass/Fail: Fail | Overall Compliance: No |

**Not Found, R304.5.1, R304.2.2, R304.5.3**

| Compliance | Description | Data | Compliance | Description | Data |
|---|---|---|---|---|---|
| N/A | Ramp Length (in) | 69.5 | No | Ramp Slope (%) | 9.8 |
| No | Ramp Width (in) | 42.5 | No | Ramp XSlope (%) | 2.2 |

**Remove & Replace Entire Ramp.**
