Access Compliance Report

Public Rights-of-Way

(Curb Ramps)

Intersection ID: 43843	Main Street: DELUCA_DR	Cross Street: ROTHMAN_LN	Location:	W
ADA ID: 24E7C7BF0B55	Ramp Type: PerpDiag	Initial Pass/Fail: Fail	Overall Compliance: No	Severity Score: 8.75
Codes/Mitigation Info/Possible Solution		Field Measurements/Component Compliance

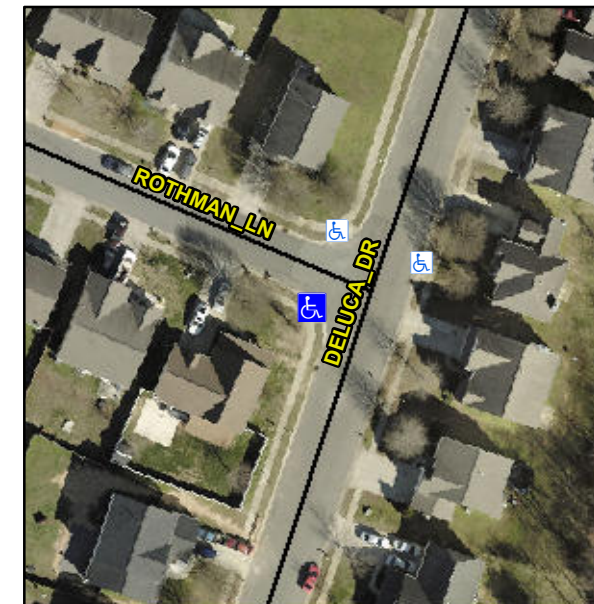
Not Found, R304.5.1

Compliance	Description	Data	Compliance	Description	Data
N/A	Ramp Length (in)	48.5	Yes	Ramp Slope (%)	6.9
No	Ramp Width (in)	47.5	Yes	Ramp XSlope (%)	1.4
N/A	Flare Type LT	N/A	N/A	Flare Type RT	N/A
N/A	Flare Slope LT (%)	N/A	N/A	Flare Slope RT (%)	N/A
N/A	Flare Traversable LT?	N/A	N/A	Flare Traversable RT?	N/A
N/A	Landing Length (in)	N/A	N/A	DWS Provided?	N/A
N/A	Landing Width (in)	N/A	N/A	DWS Contrast?	N/A
N/A	Landing Slope (%)	N/A	N/A	DWS Length (in)	N/A
N/A	Landing X Slope (%)	N/A	N/A	DWS Full Width?	N/A
N/A	Landing Curb? (Y/N)	N/A	N/A	DWS Offset (in)	N/A
N/A	Shared Landing?	N/A			
N/A	Gutter Ponding?	N/A	N/A	Gutter Slope (%)	N/A
N/A	Gutter Lip Ht (in)	N/A	N/A	Gutter X Slope (%)	N/A
N/A	Painted X Walk1?	No	N/A	Painted X Walk2?	No
	X Walk 1 Direction	To S		X Walk 2 Direction	To N
N/A	X Walk 1 Width (in)	N/A	N/A	X Walk 2 Width (in)	N/A
	X Walk 1 Slope (%)	3.8		X Walk 2 Slope (%)	2.8
	X Walk 1 X Slope (%)	1.5		X Walk 2 X Slope (%)	0.7

N/A	Ramp inside XWalk1?	N/A	N/A	Ramp inside XWalk2?	N/A
	Road Slope (%)	2.3	N/A	Clear Space?	N/A
	Road X Slope (%)	1.9	N/A	Clear Space to XWalk (in)	N/A
N/A	Any Obstructions?	N/A	N/A	Storm Grate/Utility Hazard?	N/A
	Obstruction Type			Storm Grate/Utility Type	
		N/A			N/A
			Yes	Surface Condition? (G/P)	Good

Remove & Replace Curb Ramp With Two New Directional Ramps or Equivalent.
