Access Compliance Report

Public Rights-of-Way

(Curb Ramps)

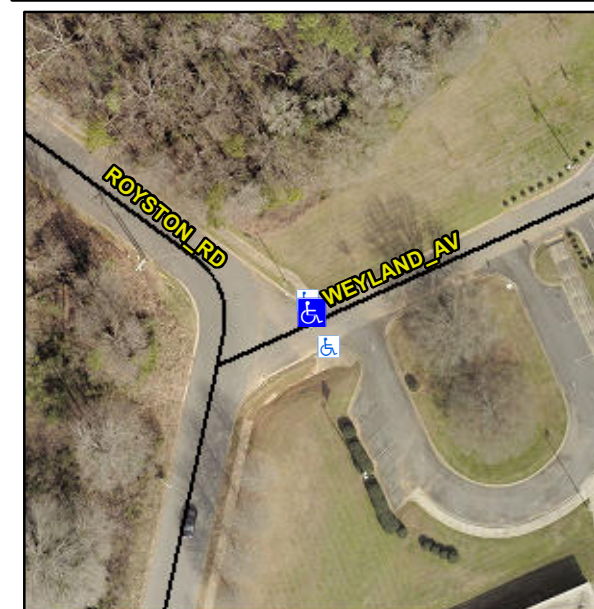
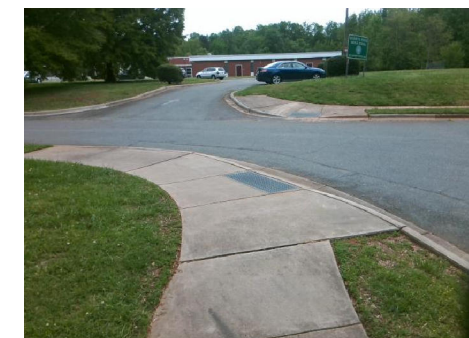
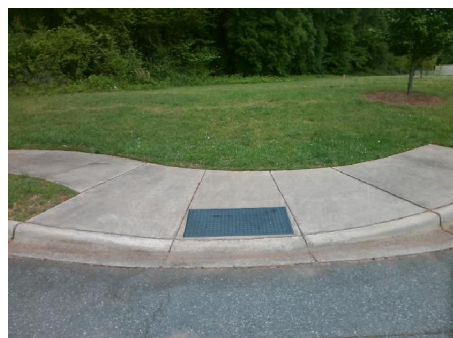
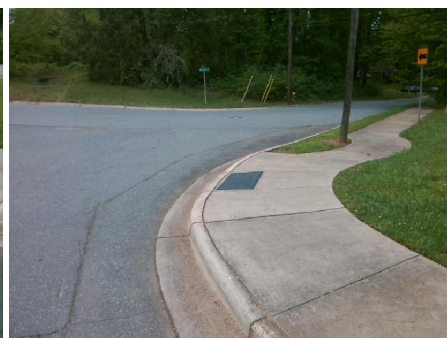
Intersection ID: 11655	Main Street: ROYSTON_RD	Cross Street: WEYLAND_AV	Location:	NE
ADA ID: 24EA16C2FF8E	Ramp Type: Combination1	Initial Pass/Fail: Fail	Overall Compliance: No	Severity Score: 10
Codes/Mitigation Info/Possible Solution		Field Measurements/Component Compliance

RT RP < 5%

Not Found, R304.5.1, R304.5.3

Compliance	Description	Data	Compliance	Description	Data
N/A	Ramp Length LT (in)	42.0	N/A	Ramp Length RT (in)	52.0
Yes	Ramp Width LT (in)	61.0	Yes	Ramp Width RT (in)	71.0
Yes	Ramp Slope LT (%)	6.7	Yes	Ramp Slope RT (%)	3.2
Yes	Ramp XSlope LT (%)	1.1	Yes	Ramp XSlope RT (%)	1.7
N/A	Ramp Length (in)	76.5	Yes	Ramp Slope (%)	7.7
No	Ramp Width (in)	42.0	No	Ramp XSlope (%)	3.2
N/A	Flare Type LT	N/A	N/A	Flare Type RT	N/A
N/A	Flare Slope LT (%)	N/A	N/A	Flare Slope RT (%)	N/A
N/A	Flare Traversable LT?	N/A	N/A	Flare Traversable RT?	N/A
N/A	Landing Length (in)	N/A	N/A	DWS Provided?	N/A
N/A	Landing Width (in)	N/A	N/A	DWS Contrast?	N/A
N/A	Landing Slope (%)	N/A	N/A	DWS Length (in)	N/A
N/A	Landing X Slope (%)	N/A	N/A	DWS Full Width?	N/A
N/A	Landing Curb? (Y/N)	N/A	N/A	DWS Offset (in)	N/A
N/A	Shared Landing?	N/A			
N/A	Gutter Ponding?	N/A	N/A	Gutter Slope (%)	N/A
N/A	Gutter Lip Ht (in)	N/A	N/A	Gutter X Slope (%)	N/A
N/A	Painted X Walk1?	No	N/A	Painted X Walk2?	N/A

X Walk 1 Direction	To SE		X Walk 2 Direction	N/A
	X Walk 1 Width (in)	N/A		X Walk 2 Width (in)	N/A
	X Walk 1 Slope (%)	3.6		X Walk 2 Slope (%)	N/A
	X Walk 1 X Slope (%)	2.0		X Walk 2 X Slope (%)	N/A
N/A	Ramp inside XWalk1?	N/A	N/A	Ramp inside XWalk2?	N/A
	Road Slope (%)	N/A		Clear Space?	N/A
	Road X Slope (%)	N/A	N/A	Clear Space to XWalk (in)	N/A
			N/A	Any Obstruction?	N/A
				Obstruction Type	N/A
			N/A	Storm Grate/Utility Hazard?	N/A
				Storm Grate/Utility Type	N/A
Yes	Surface Condition? (G/P)	Good			
	Curb Slope (%)	21.0

Possible Solutions:

Remove & Replace Entire Ramp.

Total Cost: \$ 1800.00
