Access Compliance Report Public Rights-of-Way (Curb Ramps)

Intersection ID: 22381 Main Street: FAIR_VALLEY_DR Cross Street: SHARON_VIEW_RD Location: N

ADA ID: 24EB309A892D Ramp Type: PerpDiag Initial Pass/Fail: Fail Overall Compliance: No Severity Score: 13.75

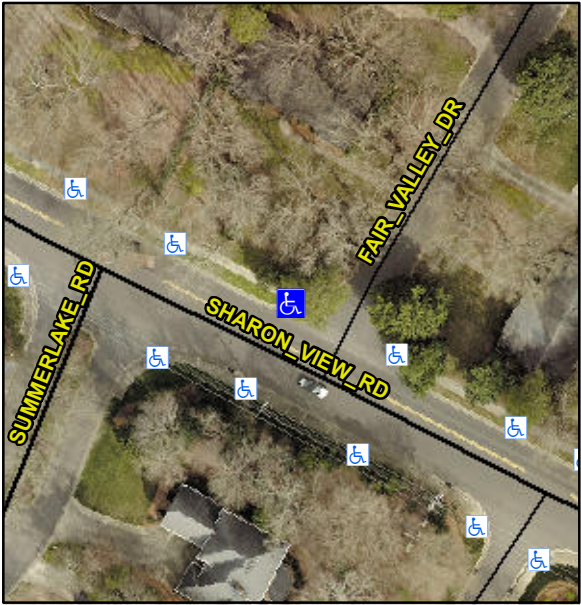
PROW/ADA:
Not Found, R304.2.2, R304.5.3

| Compliance | Description | Data | Compliance | Description | Data |
|---|---|---|---|---|---|
| N/A | Ramp Length (in) | 53.0 | No | Ramp Slope (%) | 11.9 |
| Yes | Ramp Width (in) | 48.0 | No | Ramp XSlope (%) | 4.7 |

Possible Solutions:
Remove & Replace Curb Ramp With Two New Directional Ramps or Equivalent.

Total Cost: \$ 3200.00
