Access Compliance Report

Public Rights-of-Way

(Curb Ramps)

Intersection ID: N/A	Main Street: NEW_FASHION_WY	Cross Street: N/A	Location: E
ADA ID: 24F0F8C14A6A	Ramp Type: Perp	Initial Pass/Fail: Fail	Overall Compliance: No
Severity Score: 21.25			
Codes/Mitigation Info/Possible Solution		Field Measurements/Component Compliance

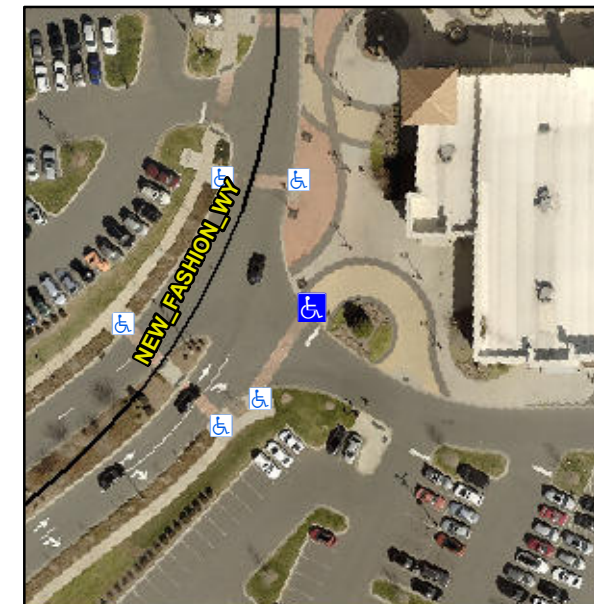
Not Found, R304.5.1, R304.2.2

Compliance	Description	Data	Compliance	Description	Data
N/A	Ramp Length (in)	61.0	No	Ramp Slope (%)	8.6
No	Ramp Width (in)	46.0	Yes	Ramp XSlope (%)	0.1
N/A	Flare Type LT	N/A	N/A	Flare Type RT	N/A
N/A	Flare Slope LT (%)	N/A	N/A	Flare Slope RT (%)	N/A
N/A	Flare Traversable LT?	N/A	N/A	Flare Traversable RT?	N/A
N/A	Landing Length (in)	N/A	N/A	DWS Provided?	N/A
N/A	Landing Width (in)	N/A	N/A	DWS Contrast?	N/A
N/A	Landing Slope (%)	N/A	N/A	DWS Length (in)	N/A
N/A	Landing X Slope (%)	N/A	N/A	DWS Full Width?	N/A
N/A	Landing Curb? (Y/N)	N/A	N/A	DWS Offset (in)	N/A
N/A	Shared Landing?	N/A			
N/A	Gutter Ponding?	N/A	N/A	Gutter Slope (%)	N/A
N/A	Gutter Lip Ht (in)	N/A	N/A	Gutter X Slope (%)	N/A
N/A	Painted X Walk1?	Yes	N/A	Painted X Walk2?	N/A
	X Walk 1 Direction	To SW		X Walk 2 Direction	N/A
N/A	X Walk 1 Width (in)	80.0	N/A	X Walk 2 Width (in)	N/A
	X Walk 1 Slope (%)	7.1		X Walk 2 Slope (%)	N/A
	X Walk 1 X Slope (%)	0.7		X Walk 2 X Slope (%)	N/A

N/A	Ramp inside XWalk1?	Yes	N/A	Ramp inside XWalk2?	N/A
	Road Slope (%)	N/A	N/A	Clear Space?	N/A
	Road X Slope (%)	N/A	N/A	Clear Space to XWalk (in)	N/A
N/A	Any Obstructions?	N/A	N/A	Storm Grate/Utility Hazard?	N/A
	Obstruction Type			Storm Grate/Utility Type	
		N/A			N/A
		Yes		Surface Condition? (G/P)	Good

Remove & Replace Entire Ramp.

Total Cost: \$ 1850.00
