# Access Compliance Report

## Public Rights-of-Way

### (Curb Ramps)

Intersection ID: 48147	Main Street: MCCAMEY_DR	Cross Street: FRANKLIN_MEADOWS_DR	Location: SW
ADA ID: 24FACD4DA089	Ramp Type: Perp	Initial Pass/Fail: Fail	Overall Compliance: No
		Severity Score: 8.75

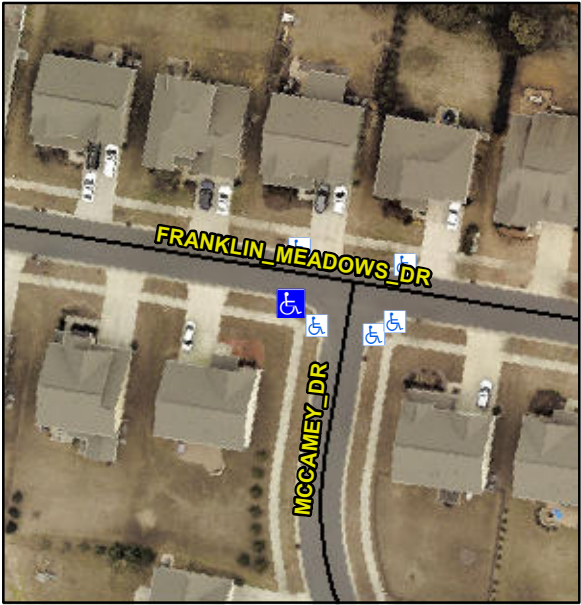
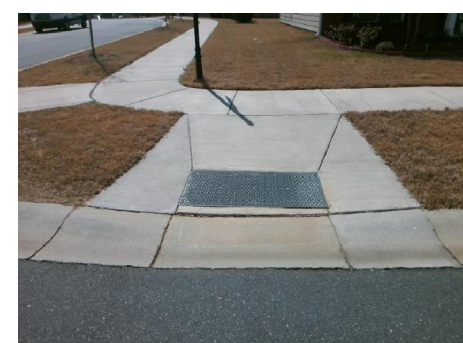
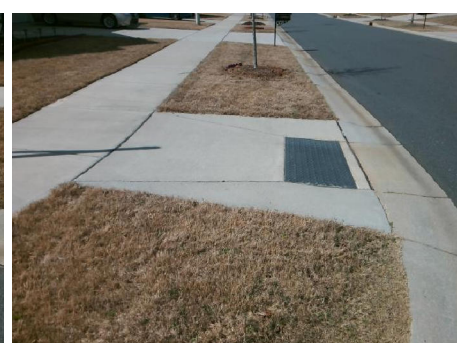
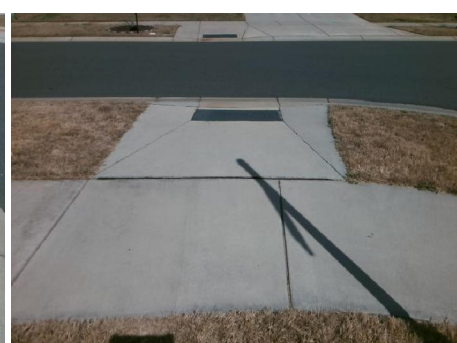
Possible Solutions:		<b>Compliance</b>	<b>Description</b>	<b>Data</b>
	<b>Remove &amp; Replace Entire Ramp.</b>		<b>Yes</b>	Ramp Length (in)	<b>96.0</b>
			<b>No</b>	Ramp Width (in)	<b>47.0</b>
			<b>N/A</b>	Flare Type LT	<b>N/A</b>
			<b>N/A</b>	Flare Slope LT (%)	<b>N/A</b>
			<b>N/A</b>	Flare Traversable LT?	<b>N/A</b>
			<b>N/A</b>	Landing Length (in)	<b>N/A</b>
			<b>N/A</b>	Landing Width (in)	<b>N/A</b>
			<b>N/A</b>	Landing Slope (%)	<b>N/A</b>
			<b>N/A</b>	Landing X Slope (%)	<b>N/A</b>
<p>Surveyor Notes:</p> <p><b>N/A</b></p> <p>PROW/ADA:</p> <p><b>Not Found, R304.5.1</b></p>			<b>N/A</b>	Flare Type RT	<b>N/A</b>
			<b>N/A</b>	Flare Slope RT (%)	<b>N/A</b>
			<b>N/A</b>	Flare Traversable RT?	<b>N/A</b>
			<b>N/A</b>	DWS Provided?	<b>N/A</b>
			<b>N/A</b>	DWS Contrast?	<b>N/A</b>
			<b>N/A</b>	DWS Length (in)	<b>N/A</b>

<b>N/A</b>	DWS Full Width?	<b>N/A</b>
			<b>N/A</b>	DWS Offset (in)	<b>N/A</b>
			<b>N/A</b>	Gutter Ponding?	<b>N/A</b>
			<b>N/A</b>	Gutter Lip Ht (in)	<b>N/A</b>
			<b>No</b>	Painted X Walk1?	<b>N/A</b>
			<b>To N</b>	X Walk 1 Direction	<b>N/A</b>
			<b>N/A</b>	X Walk 1 Width (in)	<b>N/A</b>
			<b>4.1</b>	X Walk 1 Slope (%)	<b>N/A</b>
			<b>2.0</b>	X Walk 1 X Slope (%)	<b>N/A</b>
			<b>N/A</b>	Ramp inside XWalk1?	<b>N/A</b>
			<b>N/A</b>	Road Slope (%)	<b>N/A</b>
			<b>N/A</b>	Road X Slope (%)	<b>N/A</b>
			<b>N/A</b>	Any Obstructions?	<b>N/A</b>
				Obstruction Type	
Total Cost: \$ 1850.00			<b>N/A</b>	Storm Grate/Utility Hazard?	<b>N/A</b>
			<b>N/A</b>	Storm Grate/Utility Type	<b>N/A</b>
			<b>Yes</b>	Surface Condition? (G/P)	<b>Good</b>
