Access Compliance Report

Public Rights-of-Way

(Curb Ramps)

Intersection ID: 27041	Main Street: ENDAHVEN_LN	Cross Street: ORCHID_HILL_LN	Location: NW
ADA ID: 25037E8CA8F1	Ramp Type: Perp	Initial Pass/Fail: Fail	Overall Compliance: No
Severity Score: 1.25			
Codes/Mitigation Info/Possible Solution		Field Measurements/Component Compliance

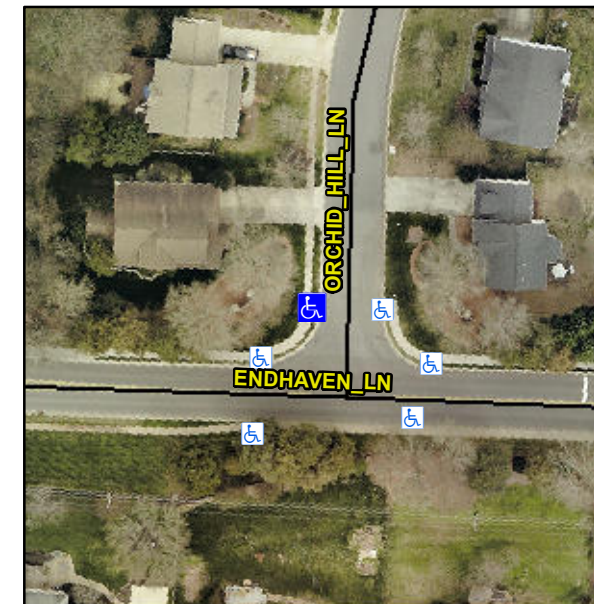
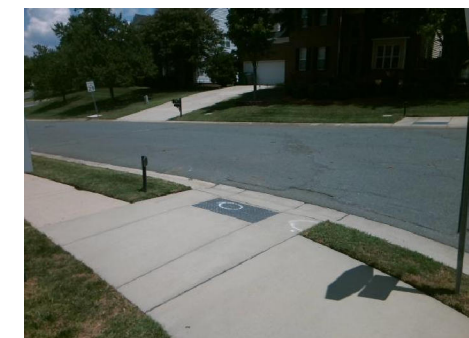
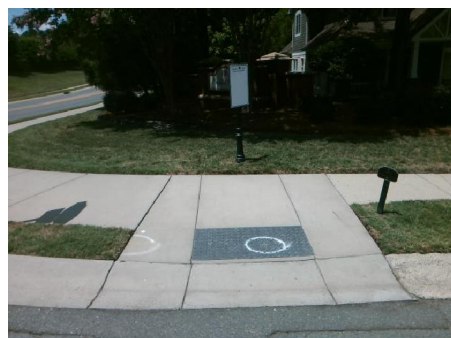
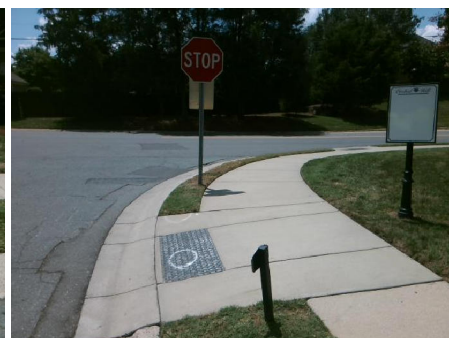
Not Found, R304.5.3

Compliance	Description	Data	Compliance	Description	Data
N/A	Ramp Length (in)	29.0	Yes	Ramp Slope (%)	7.9
Yes	Ramp Width (in)	48.0	No	Ramp XSlope (%)	2.7
N/A	Flare Type LT	N/A	N/A	Flare Type RT	N/A
N/A	Flare Slope LT (%)	N/A	N/A	Flare Slope RT (%)	N/A
N/A	Flare Traversable LT?	N/A	N/A	Flare Traversable RT?	N/A
N/A	Landing Length (in)	N/A	N/A	DWS Provided?	N/A
N/A	Landing Width (in)	N/A	N/A	DWS Contrast?	N/A
N/A	Landing Slope (%)	N/A	N/A	DWS Length (in)	N/A
N/A	Landing X Slope (%)	N/A	N/A	DWS Full Width?	N/A
N/A	Landing Curb? (Y/N)	N/A	N/A	DWS Offset (in)	N/A
N/A	Shared Landing?	N/A			
N/A	Gutter Ponding?	N/A	N/A	Gutter Slope (%)	N/A
N/A	Gutter Lip Ht (in)	N/A	N/A	Gutter X Slope (%)	N/A
N/A	Painted X Walk1?	No	N/A	Painted X Walk2?	N/A
	X Walk 1 Direction	To SE		X Walk 2 Direction	N/A
N/A	X Walk 1 Width (in)	N/A	N/A	X Walk 2 Width (in)	N/A
	X Walk 1 Slope (%)	1.6		X Walk 2 Slope (%)	N/A
	X Walk 1 X Slope (%)	3.3		X Walk 2 X Slope (%)	N/A

N/A	Ramp inside XWalk1?	N/A	N/A	Ramp inside XWalk2?	N/A
	Road Slope (%)	N/A	N/A	Clear Space?	N/A
	Road X Slope (%)	N/A	N/A	Clear Space to XWalk (in)	N/A
N/A	Any Obstructions?	N/A	N/A	Storm Grate/Utility Hazard?	N/A
	Obstruction Type			Storm Grate/Utility Type	
		N/A			N/A
			Yes	Surface Condition? (G/P)	Good

Remove & Replace Entire Ramp.
