# Access Compliance Report

## Public Rights-of-Way

### (Curb Ramps)

Intersection ID: 47141	Main Street: SARANAC_LN	Cross Street: DARLINGTON_RD	Location:	S
ADA ID: 2511C5875A33	Ramp Type: PerpDiag	Initial Pass/Fail: Fail	Overall Compliance: No	Severity Score: 10
Codes/Mitigation Info/Possible Solution		Field Measurements/Component Compliance

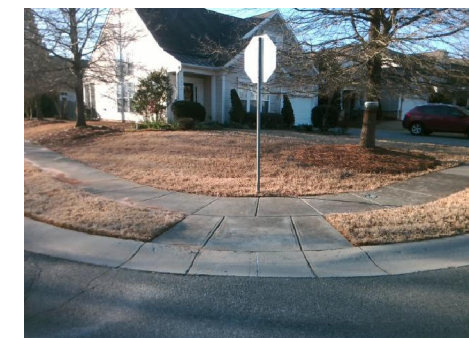
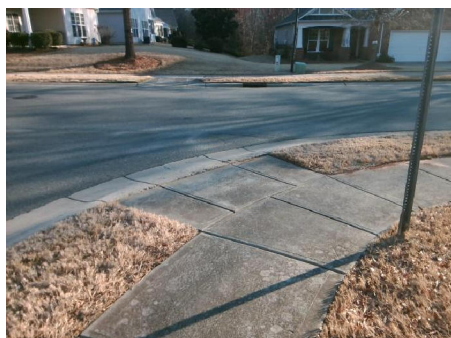
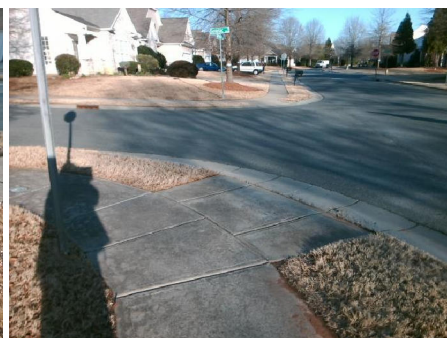
**Not Found, R304.5.1, R304.5.3**

Compliance	Description	Data	Compliance	Description	Data
N/A	Ramp Length (in)	49.0	Yes	Ramp Slope (%)	5.7
No	Ramp Width (in)	39.5	No	Ramp XSlope (%)	3.6
N/A	Flare Type LT	N/A	N/A	Flare Type RT	N/A
N/A	Flare Slope LT (%)	N/A	N/A	Flare Slope RT (%)	N/A
N/A	Flare Traversable LT?	N/A	N/A	Flare Traversable RT?	N/A
N/A	Landing Length (in)	N/A	N/A	DWS Provided?	N/A
N/A	Landing Width (in)	N/A	N/A	DWS Contrast?	N/A
N/A	Landing Slope (%)	N/A	N/A	DWS Length (in)	N/A
N/A	Landing X Slope (%)	N/A	N/A	DWS Full Width?	N/A
N/A	Landing Curb? (Y/N)	N/A	N/A	DWS Offset (in)	N/A
N/A	Shared Landing?	N/A			
N/A	Gutter Ponding?	N/A	N/A	Gutter Slope (%)	N/A
N/A	Gutter Lip Ht (in)	N/A	N/A	Gutter X Slope (%)	N/A
N/A	Painted X Walk1?	No	N/A	Painted X Walk2?	No
	X Walk 1 Direction	To NE		X Walk 2 Direction	To NW
N/A	X Walk 1 Width (in)	N/A	N/A	X Walk 2 Width (in)	N/A
	X Walk 1 Slope (%)	2.7		X Walk 2 Slope (%)	2.6
	X Walk 1 X Slope (%)	2.2		X Walk 2 X Slope (%)	0.6

N/A	Ramp inside XWalk1?	N/A	N/A	Ramp inside XWalk2?	N/A
	Road Slope (%)	2.3	N/A	Clear Space?	N/A
	Road X Slope (%)	0.4	N/A	Clear Space to XWalk (in)	N/A
N/A	Any Obstructions?	N/A	N/A	Storm Grate/Utility Hazard?	N/A
	Obstruction Type			Storm Grate/Utility Type	
		N/A			N/A
			Yes	Surface Condition? (G/P)	Good

**Remove & Replace Curb Ramp With Two New Directional Ramps or Equivalent.**
