Access Compliance Report

Public Rights-of-Way

(Curb Ramps)

Intersection ID: N/A	Main Street: INVERNESS_BAY_RD	Cross Street: ELGIN_MOOR_RD	Location: SE
ADA ID: 251577C0768B	Ramp Type: Perp	Initial Pass/Fail: Fail	Overall Compliance: No
Codes/Mitigation Info/Possible Solution		Field Measurements/Component Compliance	
Severity Score: 12.5

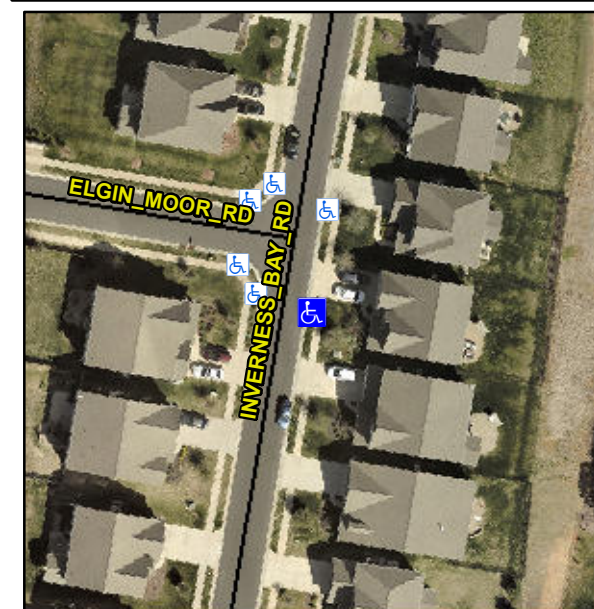
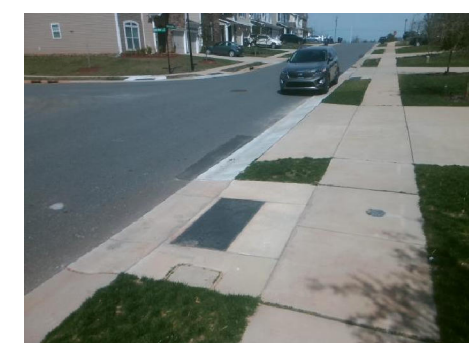
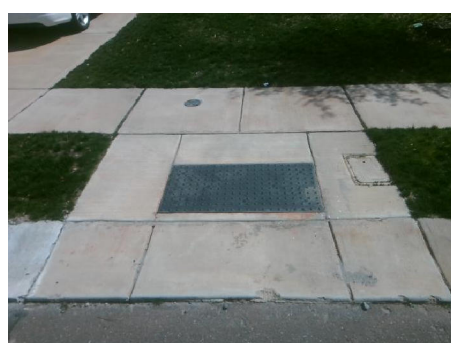
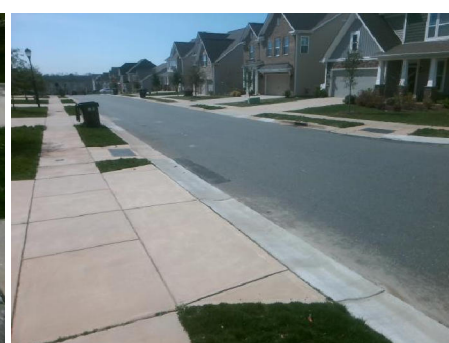
Not Found, R304.2.2

Compliance	Description	Data	Compliance	Description	Data
N/A	Ramp Length (in)	48.0	No	Ramp Slope (%)	8.5
Yes	Ramp Width (in)	48.0	Yes	Ramp XSlope (%)	0.0
N/A	Flare Type LT	N/A	N/A	Flare Type RT	N/A
N/A	Flare Slope LT (%)	N/A	N/A	Flare Slope RT (%)	N/A
N/A	Flare Traversable LT?	N/A	N/A	Flare Traversable RT?	N/A
N/A	Landing Length (in)	N/A	N/A	DWS Provided?	N/A
N/A	Landing Width (in)	N/A	N/A	DWS Contrast?	N/A
N/A	Landing Slope (%)	N/A	N/A	DWS Length (in)	N/A
N/A	Landing X Slope (%)	N/A	N/A	DWS Full Width?	N/A
N/A	Landing Curb? (Y/N)	N/A	N/A	DWS Offset (in)	N/A
N/A	Shared Landing?	N/A			
N/A	Gutter Ponding?	N/A	N/A	Gutter Slope (%)	N/A
N/A	Gutter Lip Ht (in)	1.0	N/A	Gutter X Slope (%)	N/A
N/A	Painted X Walk1?	No	N/A	Painted X Walk2?	N/A
	X Walk 1 Direction	To NW		X Walk 2 Direction	N/A
N/A	X Walk 1 Width (in)	N/A	N/A	X Walk 2 Width (in)	N/A
	X Walk 1 Slope (%)	3.9		X Walk 2 Slope (%)	N/A
	X Walk 1 X Slope (%)	1.6		X Walk 2 X Slope (%)	N/A

N/A	Ramp inside XWalk1?	N/A	N/A	Ramp inside XWalk2?	N/A
	Road Slope (%)	N/A	N/A	Clear Space?	N/A
	Road X Slope (%)	N/A	N/A	Clear Space to XWalk (in)	N/A
N/A	Any Obstructions?	N/A	N/A	Storm Grate/Utility Hazard?	N/A
	Obstruction Type			Storm Grate/Utility Type	
		N/A			N/A
			Yes	Surface Condition? (G/P)	Good

Possible Solutions:

Remove & Replace Entire Ramp.

Total Cost: \$ 1850.00
