## Access Compliance Report Public Rights-of-Way (Curb Ramps)

Intersection ID: 47463Main Street:DOMINION\_VILLAGE\_DRCross Street:DOMINION\_GREEN\_DRLocation:NEADA ID: 2526E7D8E0E9Ramp Type:PerpInitial Pass/Fail:FailOverall Compliance:NoSeverity Score:25

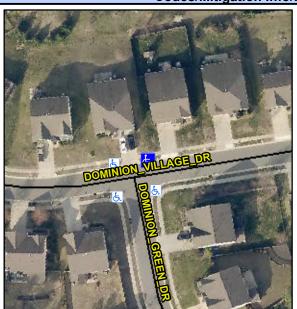
Field Measurements/Component Compliance									
Compliance Description		Data	Comp	liance	Description	Data			
N/A	Ramp Length (in)	48.0	No	Ramp	Slope (%)	8.5			
Yes	Ramp Width (in)	52.0	No	Ramp	XSlope (%)	5.3			
N/A	Flare Type LT	N/A	N/A	Flare	Type RT	N/A			
N/A	Flare Slope LT (%)	N/A	N/A	Flare	Slope RT (%)	N/A			
N/A	Flare Traversable LT?	N/A	N/A	Flare	Traversable RT?	N/A			
N/A	Landing Length (in)	N/A	N/A	DWS	Provided?	N/A			
N/A	Landing Width (in)	N/A	N/A	DWS	Contrast?	N/A			
N/A	Landing Slope (%)	N/A	N/A	DWS	Length (in)	N/A			
N/A	Landing X Slope (%)	N/A	N/A	DWS	Full Width?	N/A			
N/A	Landing Curb? (Y/N)	N/A	N/A	DWS	Offset (in)	N/A			
N/A	Shared Landing?	N/A							
N/A	Gutter Ponding?	N/A	N/A	Gutte	r Slope (%)	N/A			
N/A	Gutter Lip Ht (in)	N/A	N/A	Gutte	r X Slope (%)	N/A			
N/A	Painted X Walk1?	No	N/A	Paint	ed X Walk2?	N/A			
	X Walk 1 Direction	To S		X Wa	lk 2 Direction	N/A			
N/A	X Walk 1 Width (in)	N/A	N/A	X Wa	lk 2 Width (in)	N/A

X Walk 1 Slope (%)	3.5		X Wa	lk 2 Slope (%)	N/A			
	X Walk 1 X Slope (%)	3.8		X Wa	lk 2 X Slope (%)	N/A			
N/A	Ramp inside XWalk1?	N/A	N/A	Ram	inside XWalk2?	N/A			
	Road Slope (%)	N/A	N/A	Clear	Space?	N/A			
	Road X Slope (%)	N/A	N/A	Clear	Space to XWalk (in)	N/A			
N/A	Any Obstructions?	N/A	N/A	Storn	n Grate/Utility Hazard?	N/A			
	Obstruction Type			Storn	n Grate/Utility Type				
		N/A				N/A			
			Yes	Surfa	ce Condition? (G/P)	Good

4	1 CCCIDIO CCIALICII	
1	Possible Solutions:	<u>C</u>
100	Remove & Replace Entire Ramp.	N/
		Ye
2		N/
1		N/
		N/
- emil		N/
i	Surveyor Notes:	N/
0.000	N/A	N/
		N/
No. of Lot		N/
		N/
Į.	PROW/ADA:	N/
Ì	Not Found, R304.2.2, R304.5.3	N/
Section 2		N/
Application of the last		
		N/
		N/
