Intersection ID: 10275	Main Street: DIXON_ST	Cross Street: SOLOMON_ST	Location:	SW
ADA ID: 2527CBE44883	Ramp Type: Perp	Initial Pass/Fail: Fail	Overall Compliance: No	Severity Score: 12.5

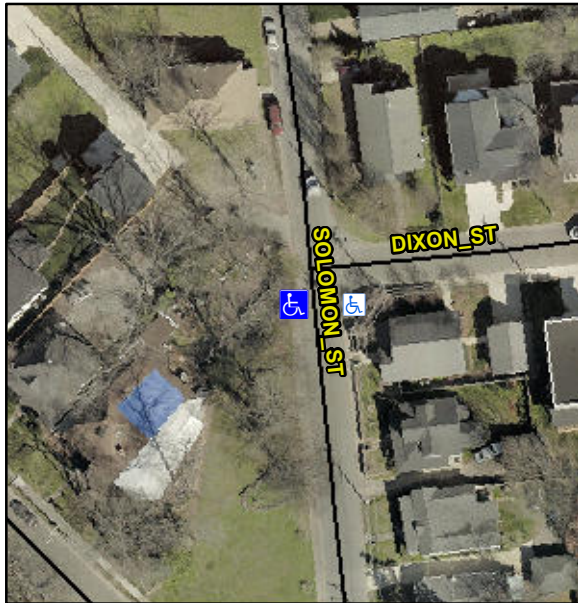
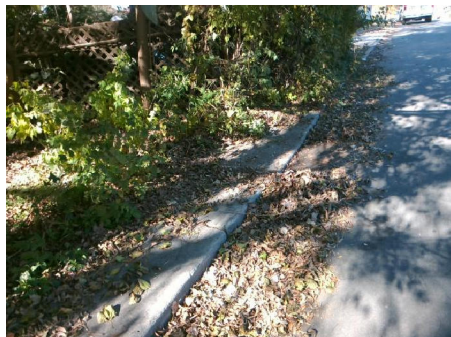
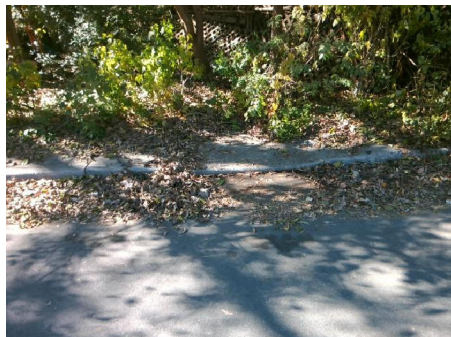
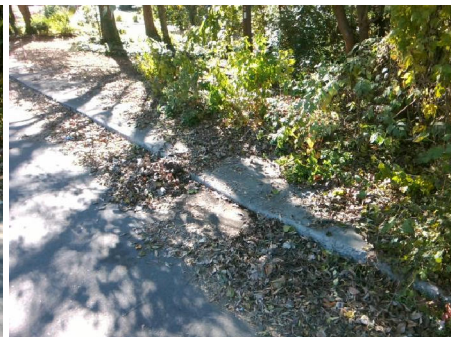
R304.5.3

Possible Solutions:			Compliance	Description	Data	Compliance	Description	Data
Remove & Replace Entire Ramp.	N/A	Ramp Length (in)	43.0	Yes	Ramp Slope (%)	6.1		
	Yes	Ramp Width (in)	48.0	No	Ramp XSlope (%)	5.1		
	N/A	Flare Type LT	N/A	N/A	Flare Type RT	N/A		
	N/A	Flare Slope LT (%)	N/A	N/A	Flare Slope RT (%)	N/A		
	N/A	Flare Traversable LT?	N/A	N/A	Flare Traversable RT?	N/A		
	N/A	Landing Length (in)	N/A	N/A	DWS Provided?	N/A		
	N/A	Landing Width (in)	N/A	N/A	DWS Contrast?	N/A		
	N/A	Landing Slope (%)	N/A	N/A	DWS Length (in)	N/A		
	N/A	Landing X Slope (%)	N/A	N/A	DWS Full Width?	N/A		
	N/A	Landing Curb? (Y/N)	N/A	N/A	DWS Offset (in)	N/A		
Surveyor Notes: N/A	N/A	Shared Landing?	N/A					
	N/A	Gutter Ponding?	N/A	N/A	Gutter Slope (%)	N/A		
	N/A	Gutter Lip Ht (in)	N/A	N/A	Gutter X Slope (%)	N/A		
	N/A	Painted X Walk1?	No	N/A	Painted X Walk2?	N/A		
		X Walk 1 Direction	To E		X Walk 2 Direction	N/A		
	N/A	X Walk 1 Width (in)	N/A	N/A	X Walk 2 Width (in)	N/A

X Walk 1 Slope (%)	4.6		X Walk 2 Slope (%)	N/A		
		X Walk 1 X Slope (%)	4.7		X Walk 2 X Slope (%)	N/A		
	N/A	Ramp inside XWalk1?	N/A	N/A	Ramp inside XWalk2?	N/A		
		Road Slope (%)	N/A	N/A	Clear Space?	N/A		
PROW/ADA: R304.5.3		Road X Slope (%)	N/A	N/A	Clear Space to XWalk (in)	N/A		
	N/A	Any Obstructions?	N/A	N/A	Storm Grate/Utility Hazard?	N/A		
		Obstruction Type			Storm Grate/Utility Type			
			N/A			N/A		
				Yes	Surface Condition? (G/P)	Good		
	Total Cost:	\$	1850.00

Remove & Replace Entire Ramp.
