Access Compliance Report

Public Rights-of-Way

(Curb Ramps)

Intersection ID: 4394	Main Street: OLD_STATESVILLE_RD	Cross Street: VICTORIA_AV	Location: SE
ADA ID: 2549A263CB03	Ramp Type: Perp	Initial Pass/Fail: Fail	Overall Compliance: No
		Severity Score: 25

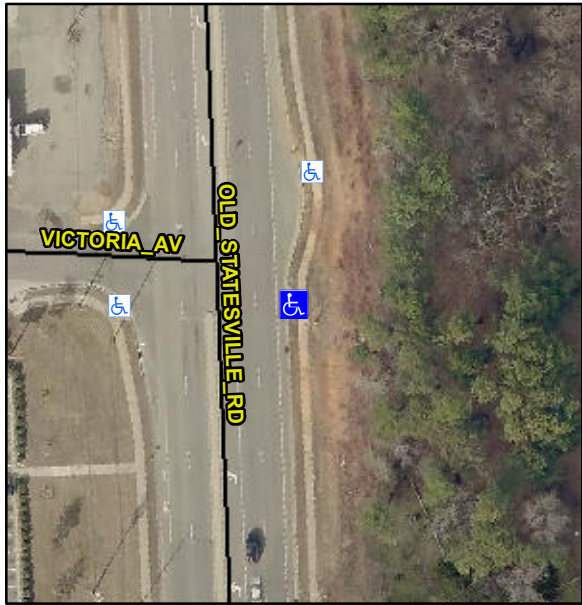
Possible Solutions:		Compliance	Description	Data	Compliance	Description	Data
	Remove & Replace Entire Ramp.		N/A	Ramp Length (in)	61.0	No	Ramp Slope (%)	20.0
			Yes	Ramp Width (in)	48.0	Yes	Ramp XSlope (%)	1.1
			N/A	Flare Type LT	N/A	N/A	Flare Type RT	N/A
			N/A	Flare Slope LT (%)	N/A	N/A	Flare Slope RT (%)	N/A
			N/A	Flare Traversable LT?	N/A	N/A	Flare Traversable RT?	N/A
			N/A	Landing Length (in)	N/A	N/A	DWS Provided?	N/A
			N/A	Landing Width (in)	N/A	N/A	DWS Contrast?	N/A
			N/A	Landing Slope (%)	N/A	N/A	DWS Length (in)	N/A
			N/A	Landing X Slope (%)	N/A	N/A	DWS Full Width?	N/A
Surveyor Notes:		N/A	N/A	Landing Curb? (Y/N)	N/A	N/A	DWS Offset (in)	N/A
		N/A	N/A	Shared Landing?	N/A			
PROW/ADA:		N/A	N/A	Gutter Ponding?	N/A	N/A	Gutter Slope (%)	N/A
		Not Found, R304.2.2	N/A	Gutter Lip Ht (in)	N/A	N/A	Gutter X Slope (%)	N/A
