Access Compliance Report Public Rights-of-Way (Curb Ramps)

Intersection ID: 17945 Main Street: E WOODLAWN RD **Cross Street: MURRAYHILL RD** Location: SW **Overall Compliance: No** Severity Score: 26.25 ADA ID: 254B98603177 Ramp Type: Combination2 Initial Pass/Fail: Fail

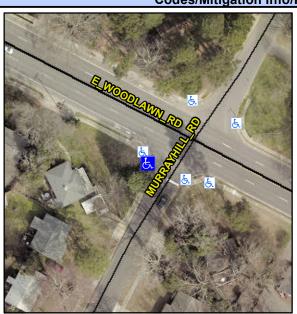
Compliance Description Possible Solutions: N/A Remove & Replace Entire Ramp. N/A N/A N/A N/A Yes Surveyor Notes: N/A N/A N/A N/A N/A N/A PROW/ADA: N/A Not Found, R304.5.3, R304.3.2
