Access Compliance Report Public Rights-of-Way (Curb Ramps)

Main Street: BALLANTYNE CORPORATE PCross Street: N/A Location: Intersection ID: 10020377 NE

Overall Compliance: No ADA ID: 2553DBBA8F9D Ramp Type: BlendTrans1 Initial Pass/Fail: Fail Severity Score: 21.25

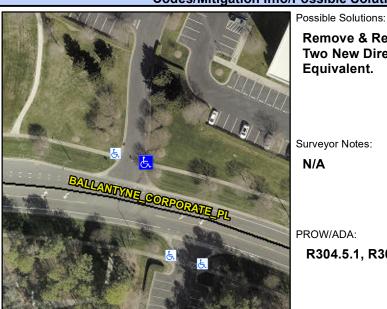
N/A	Ramp Length (in)	65.0	Yes
No	Ramp Width (in)	47.0	No
N/A	Flare Type LT	N/A	N/A
N/A	Flare Slope LT (%)	N/A	N/A
N/A	Flare Traversable LT?	N/A	N/A
N/A	Landing Length (in)	N/A	N/A
N/A	Landing Width (in)	N/A	N/A
N/A	Landing Slope (%)	N/A	N/A
N/A	Landing X Slope (%)	N/A	N/A
N/A	Landing Curb? (Y/N)	N/A	N/A
N/A	Shared Landing?	N/A	
N/A	Gutter Ponding?	N/A	N/A
N/A	Gutter Lip Ht (in)	N/A	N/A
N/A	Painted X Walk1?	No	N/A
	X Walk 1 Direction	To W	
	X Walk 1 Width (in)	N/A	
	X Walk 1 Slope (%)	2.2	
	X Walk 1 X Slope (%)	5.5	
N/A	Ramp inside XWalk1?	N/A	N/A
	Road Slope (%)	5.5	
	Road X Slope (%)	2.2	N/A
N/A	Any Obstructions?	N/A	N/A

ENTRANCE Street 1 Name Stop Condition-Street 1 StopSign N/A Street 2 Name N/A Remove & Replace Curb Ramp With Two New Directional Ramps or Equivalent.

R304.5.1, R304.5.3
