# Access Compliance Report

## Public Rights-of-Way (Curb Ramps)

Intersection ID: 44731	Main Street: BENFIELD_RD	Cross Street: PROSPERITY_PARK_DR	Location: E
ADA ID: 255686CF2F1F	Ramp Type: PerpDiag	Initial Pass/Fail: Fail	Overall Compliance: No
Severity Score: 37.5			
Codes/Mitigation Info/Possible Solution		Field Measurements/Component Compliance

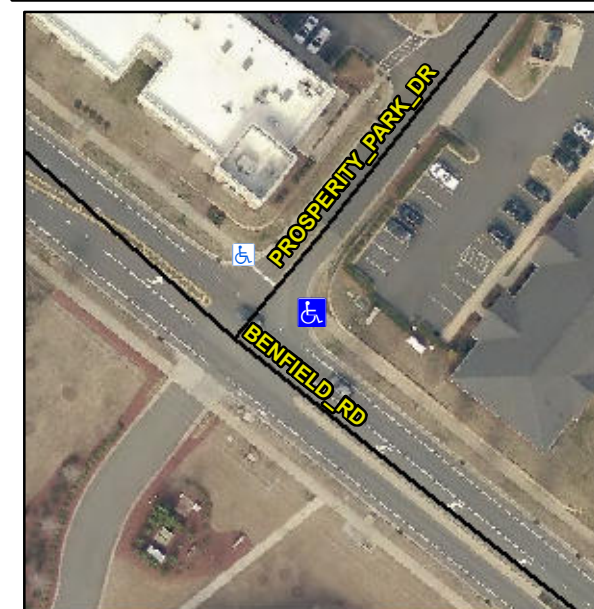
Compliance	Description	Data	Compliance	Description	Data
N/A	Ramp Length (in)	60.0	No	Ramp Slope (%)	20.0
Yes	Ramp Width (in)	49.0	No	Ramp XSlope (%)	5.1
N/A	Flare Type LT	N/A	N/A	Flare Type RT	N/A
N/A	Flare Slope LT (%)	N/A	N/A	Flare Slope RT (%)	N/A
N/A	Flare Traversable LT?	N/A	N/A	Flare Traversable RT?	N/A
N/A	Landing Length (in)	N/A	N/A	DWS Provided?	N/A
N/A	Landing Width (in)	N/A	N/A	DWS Contrast?	N/A
N/A	Landing Slope (%)	N/A	N/A	DWS Length (in)	N/A
N/A	Landing X Slope (%)	N/A	N/A	DWS Full Width?	N/A
N/A	Landing Curb? (Y/N)	N/A	N/A	DWS Offset (in)	N/A
N/A	Shared Landing?	N/A			
N/A	Gutter Ponding?	N/A	N/A	Gutter Slope (%)	N/A
N/A	Gutter Lip Ht (in)	N/A	N/A	Gutter X Slope (%)	N/A
N/A	Painted X Walk1?	No	N/A	Painted X Walk2?	No
	X Walk 1 Direction	To SW		X Walk 2 Direction	To NW
N/A	X Walk 1 Width (in)	N/A	N/A	X Walk 2 Width (in)	N/A
	X Walk 1 Slope (%)	2.5		X Walk 2 Slope (%)	3.0
	X Walk 1 X Slope (%)	1.0		X Walk 2 X Slope (%)	1.3

N/A	Ramp inside XWalk1?	N/A	N/A	Ramp inside XWalk2?	N/A
	Road Slope (%)	2.8	N/A	Clear Space?	N/A
	Road X Slope (%)	2.2	N/A	Clear Space to XWalk (in)	N/A
N/A	Any Obstructions?	N/A	N/A	Storm Grate/Utility Hazard?	N/A
	Obstruction Type			Storm Grate/Utility Type	
		N/A			N/A
			Yes	Surface Condition? (G/P)	Good

**Remove & Replace Curb Ramp With Two New Directional Ramps or Equivalent.**

**R304.2.2, R304.5.3**
